**CITY OF REDMOND**  
**FACILITY CONDITION ASSESSMENT**  
**15 MARCH 2014**

## **I. EXECUTIVE SUMMARY**

### **1.1 Introduction**

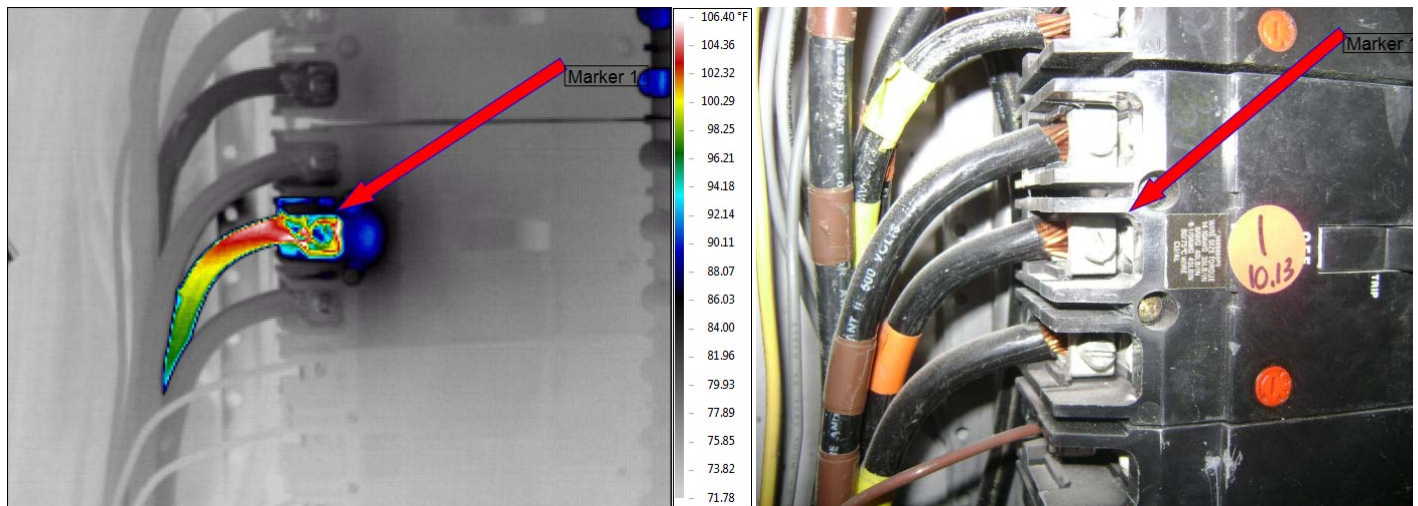
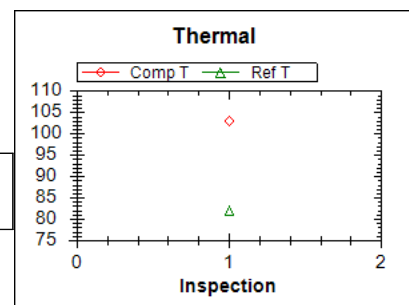
**Comment:** B phase load side wire lug connection on 100amp breaker "Panel 1XB2 (rm 164) via XRMR"

| Insp.# | Prob.# | Date | Comp Temp | Ref. Temp | Temp Rise | Sev. Code | Load | % Load | Wind Spd. | Amb. Temp |
|---|---|---|---|---|---|---|---|---|---|---|
| 1 | 1 | 10/28/2013 | 103.0 | 82.0 | 21.0 | 4 | | N/A | | 70.0 |

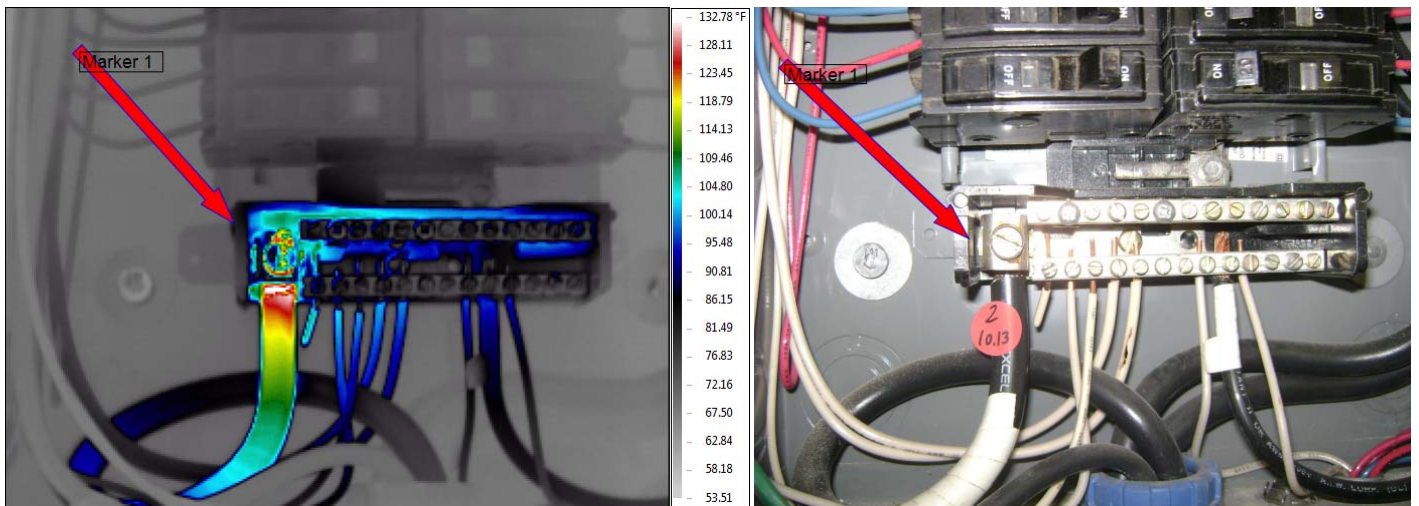
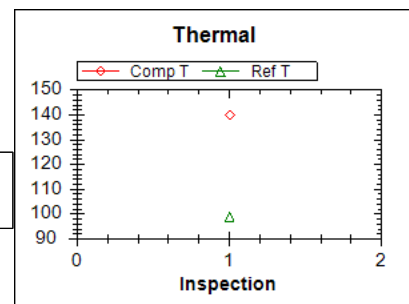
**Comment:** Stripped lug on main neutral wire on terminal strip

| Insp.# | Prob.# | Date | Comp Temp | Ref. Temp | Temp Rise | Sev. Code | Load | % Load | Wind Spd. | Amb. Temp |
|---|---|---|---|---|---|---|---|---|---|---|
| 1 | 2 | 10/28/2013 | 140.0 | 99.0 | 41.0 | 3 | N/A | | | 70.0 |

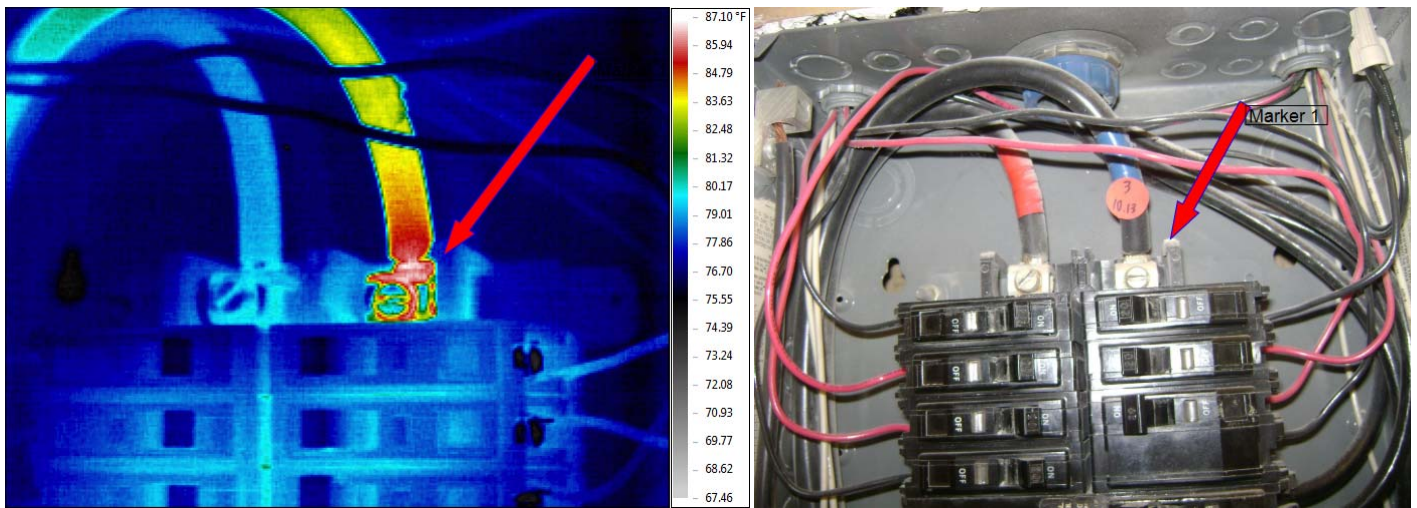
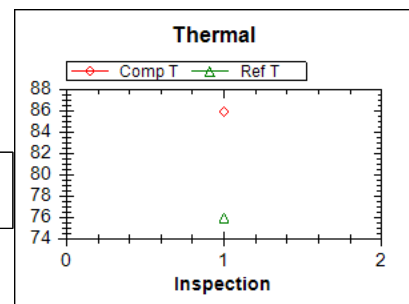
**Comment:** B phase line side wire lug connection on incoming lines

| Insp.# | Prob.# | Date | Comp Temp | Ref. Temp | Temp Rise | Sev. Code | Load | % Load | Wind Spd. | Amb. Temp |
|---|---|---|---|---|---|---|---|---|---|---|
| 1 | 3 | 10/28/2013 | 86.0 | 76.0 | 10.0 | 4 | | N/A | | 70.0 |

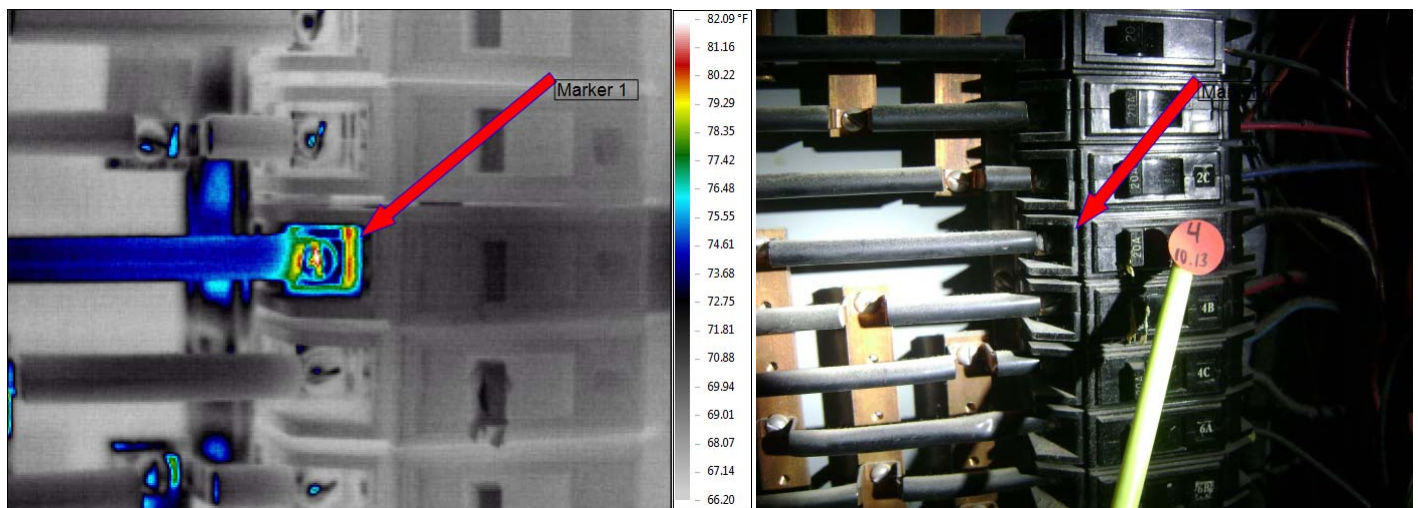
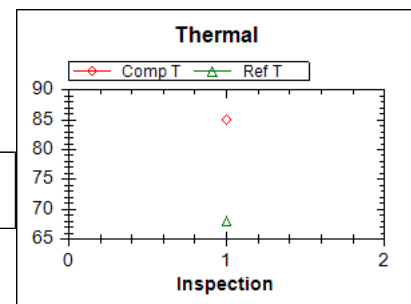
**Comment:** Line side bolt to bus connection on Breaker 4A "House Balcony"

| Insp.# | Prob.# | Date | Comp Temp | Ref. Temp | Temp Rise | Sev. Code | Load | % Load | Wind Spd. | Amb. Temp |
|---|---|---|---|---|---|---|---|---|---|---|
| 1 | 4 | 10/29/2013 | 85.0 | 68.0 | 17.0 | 4 | 6.6 | 33.0% | | 70.0 |

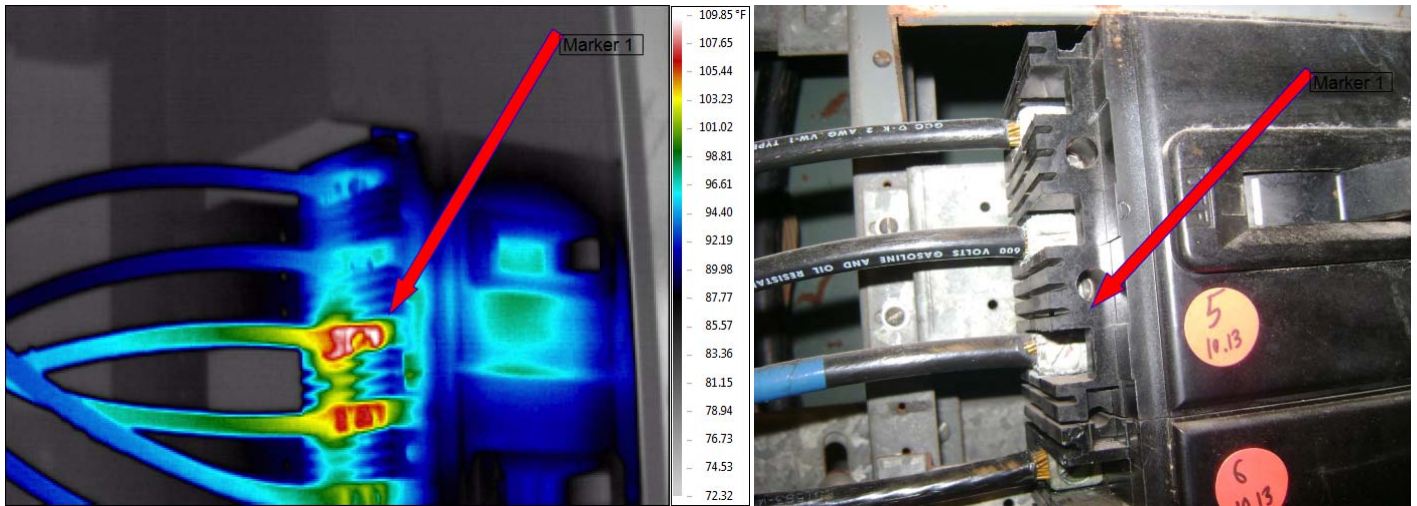
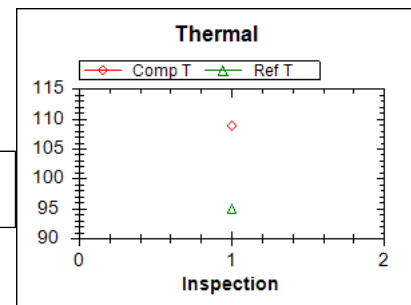
**Comment:** C phase load side wire lug connection an breaker "Panel BR"

| Insp.# | Prob.# | Date | Comp Temp | Ref. Temp | Temp Rise | Sev. Code | Load | % Load | Wind Spd. | Amb. Temp |
|---|---|---|---|---|---|---|---|---|---|---|
| 1 | 5 | 10/29/2013 | 109.0 | 95.0 | 14.0 | 4 | 27 | 27.0% | | 85.0 |

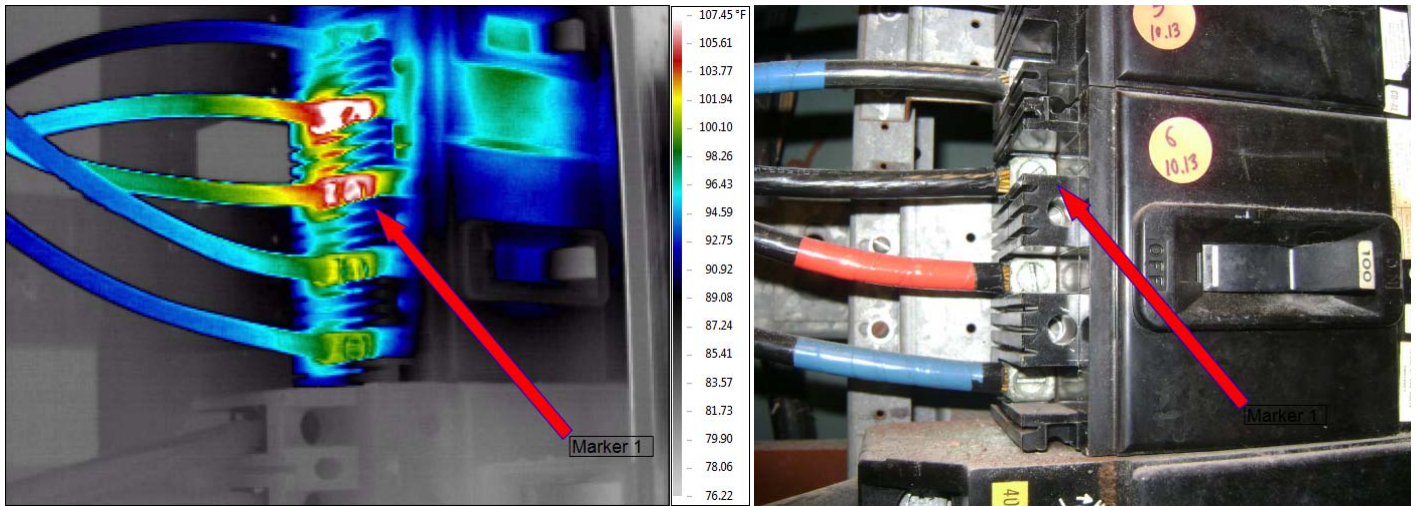
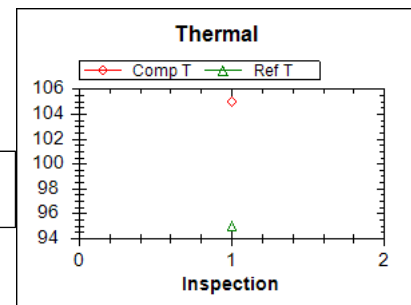
**Comment:** A phase load side wire lug connection on Breaker "Pump"

| Insp.# | Prob.# | Date | Comp Temp | Ref. Temp | Temp Rise | Sev. Code | Load | % Load | Wind Spd. | Amb. Temp |
|---|---|---|---|---|---|---|---|---|---|---|
| 1 | 6 | 10/29/2013 | 105.0 | 95.0 | 10.0 | 4 | 40 | 40.0% | | 85.0 |

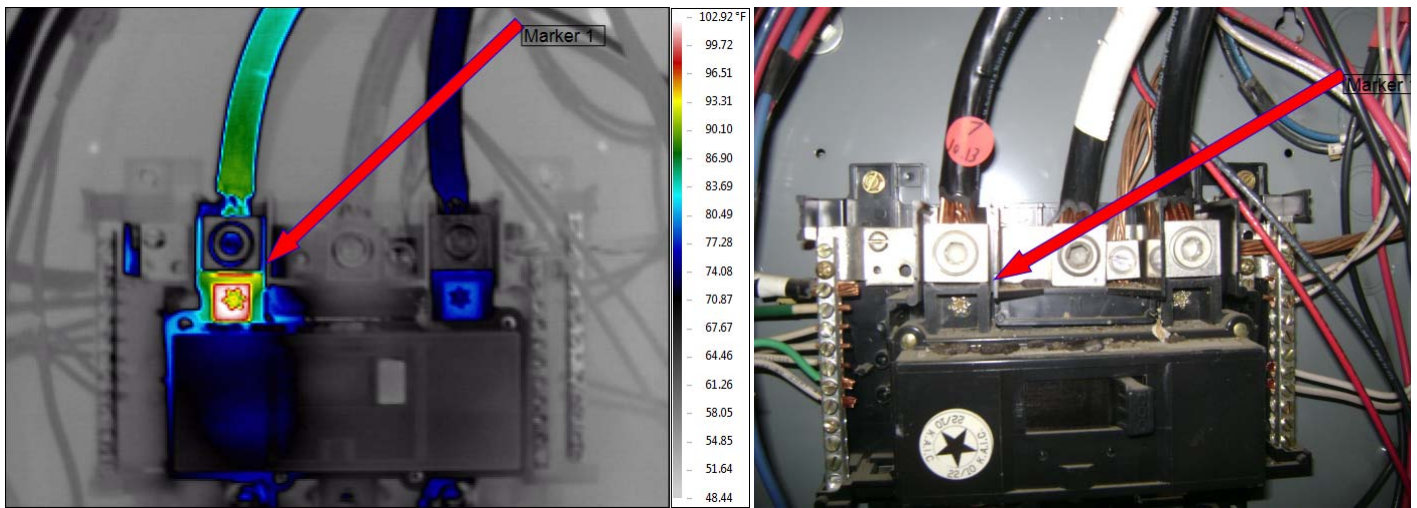
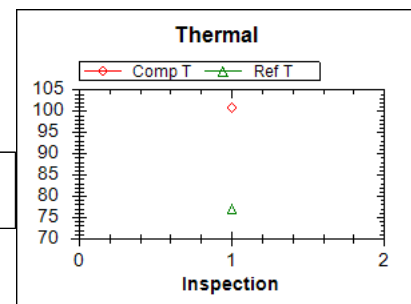
**Comment:** A phase line side wire lug connection on incoming main lines

| Insp.# | Prob.# | Date | Comp Temp | Ref. Temp | Temp Rise | Sev. Code | Load | % Load | Wind Spd. | Amb. Temp |
|---|---|---|---|---|---|---|---|---|---|---|
| 1 | 7 | 10/30/2013 | 101.0 | 77.0 | 24.0 | 3 | 80 | 40.0% | | 51.0 |

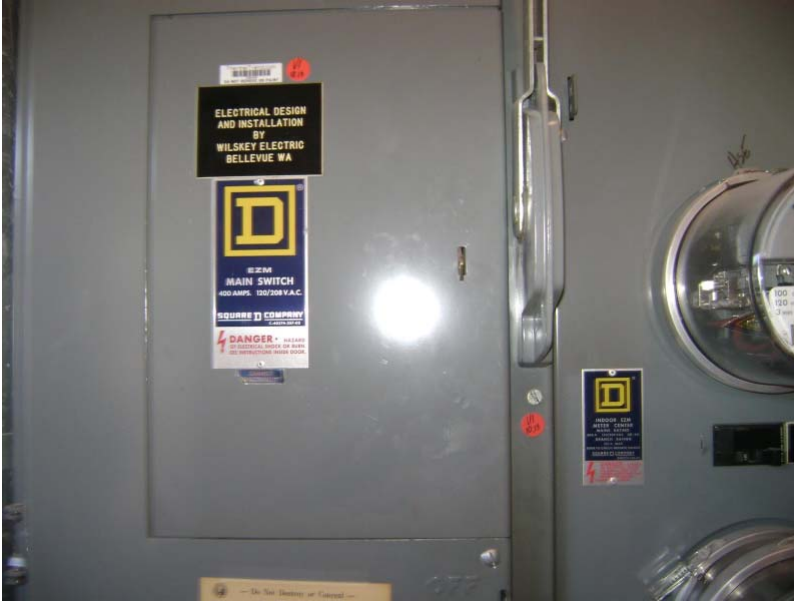
**Description:** Safety Bypass is broken

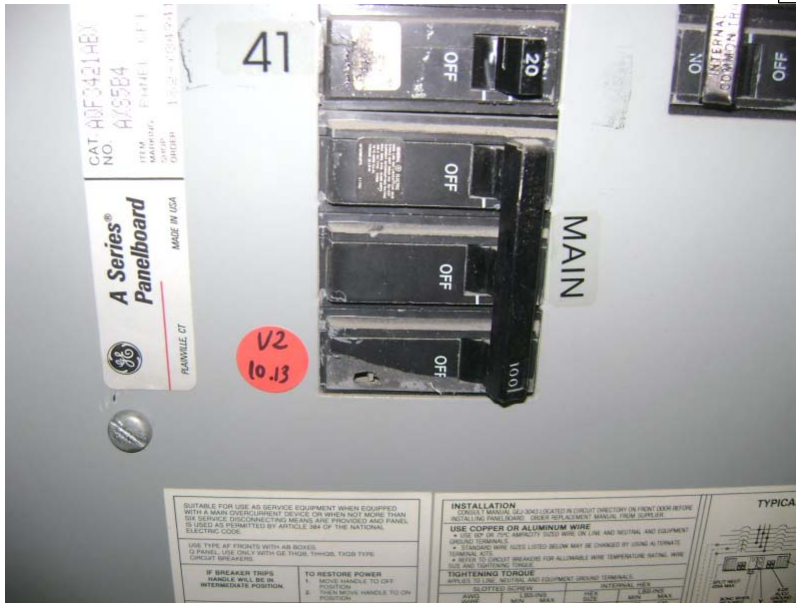
**Description:** Main Breaker is broken, exposed metal on C phase of 3-pole 100amp breaker

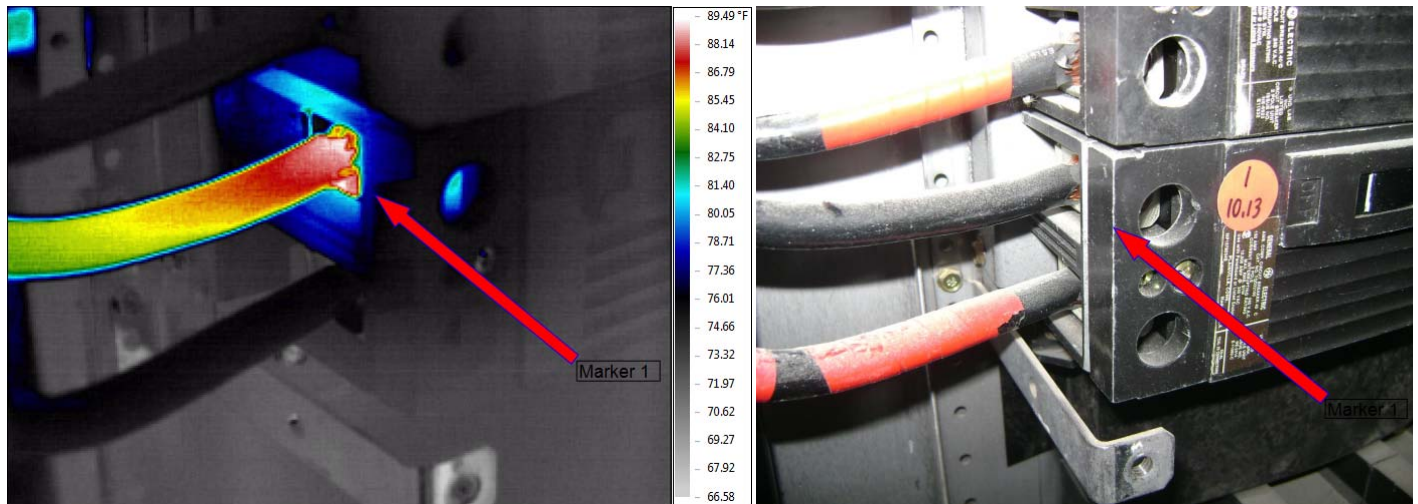
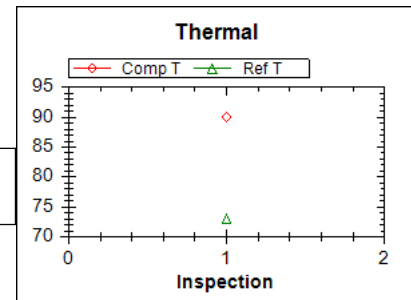
**Comment:** A phase load side wire lug connection on 2-pole Breaker "Panel E To ATS Normal"

| Insp.# | Prob.# | Date | Comp Temp | Ref. Temp | Temp Rise | Sev. Code | Load | % Load | Wind Spd. | Amb. Temp |
|---|---|---|---|---|---|---|---|---|---|---|
| 1 | 1 | 10/30/2013 | 90.0 | 73.0 | 17.0 | 4 | 25 | 16.7% | | 70.0 |

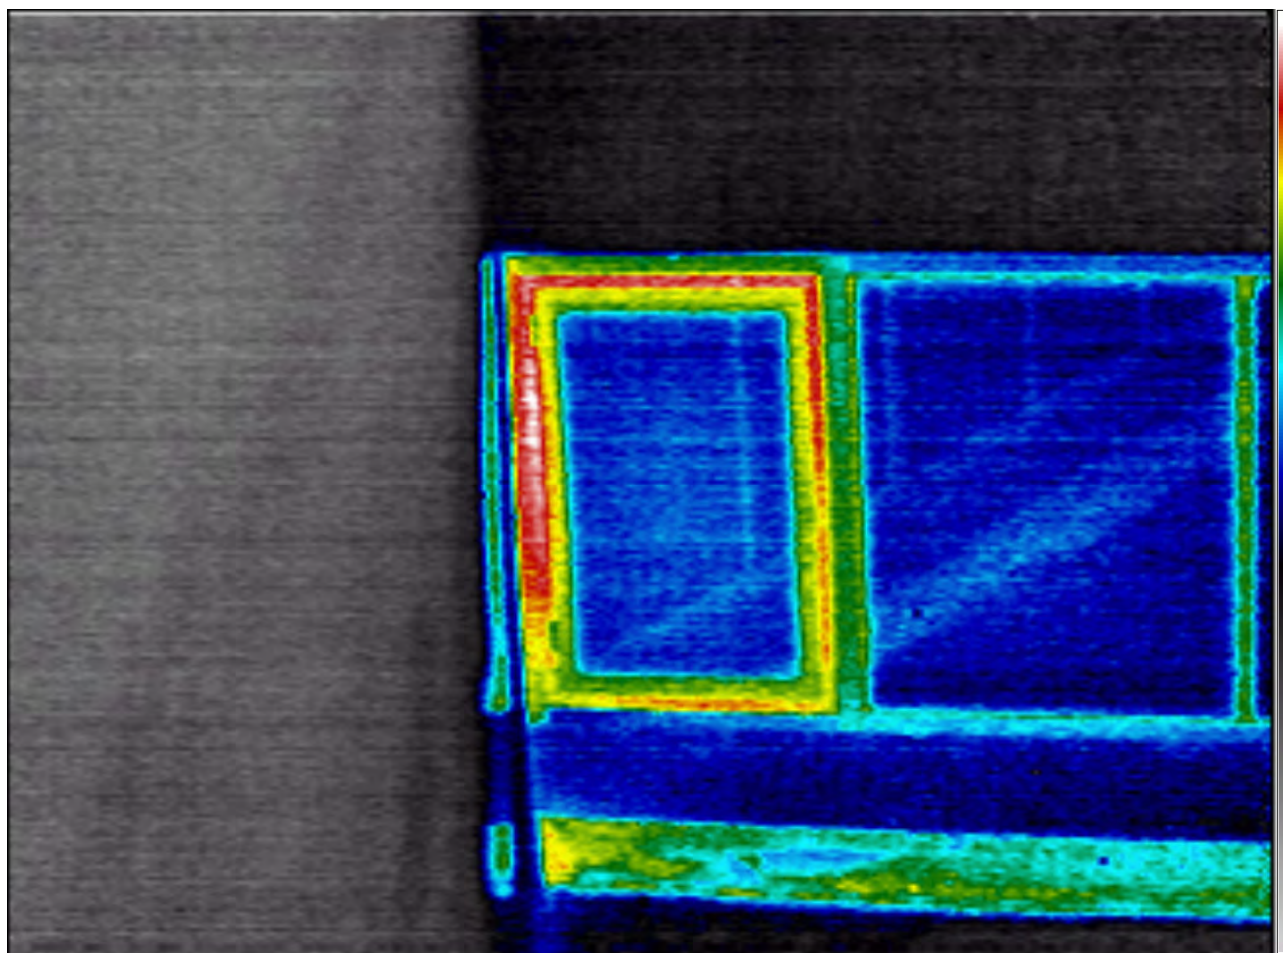
3<sup>rd</sup> Floor, roof level above main entrance

Heat escaping around the window/door seal for the south window that is used as a access point to the outside roof level.

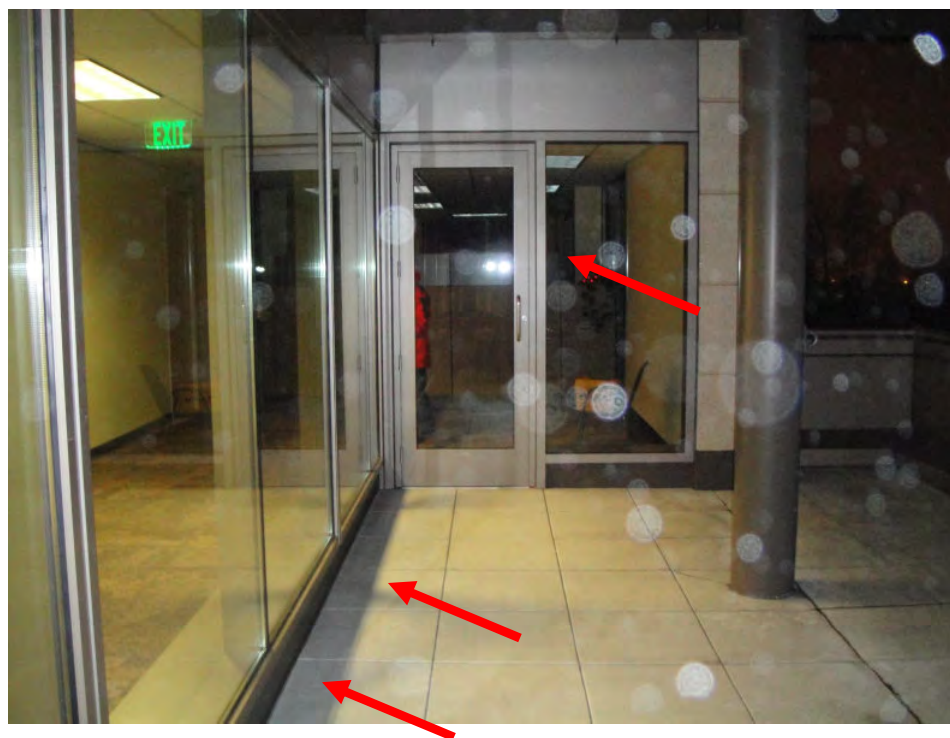
## 4<sup>th</sup> Floor, North Balcony

Heat escape from the West door frame and base of south wall

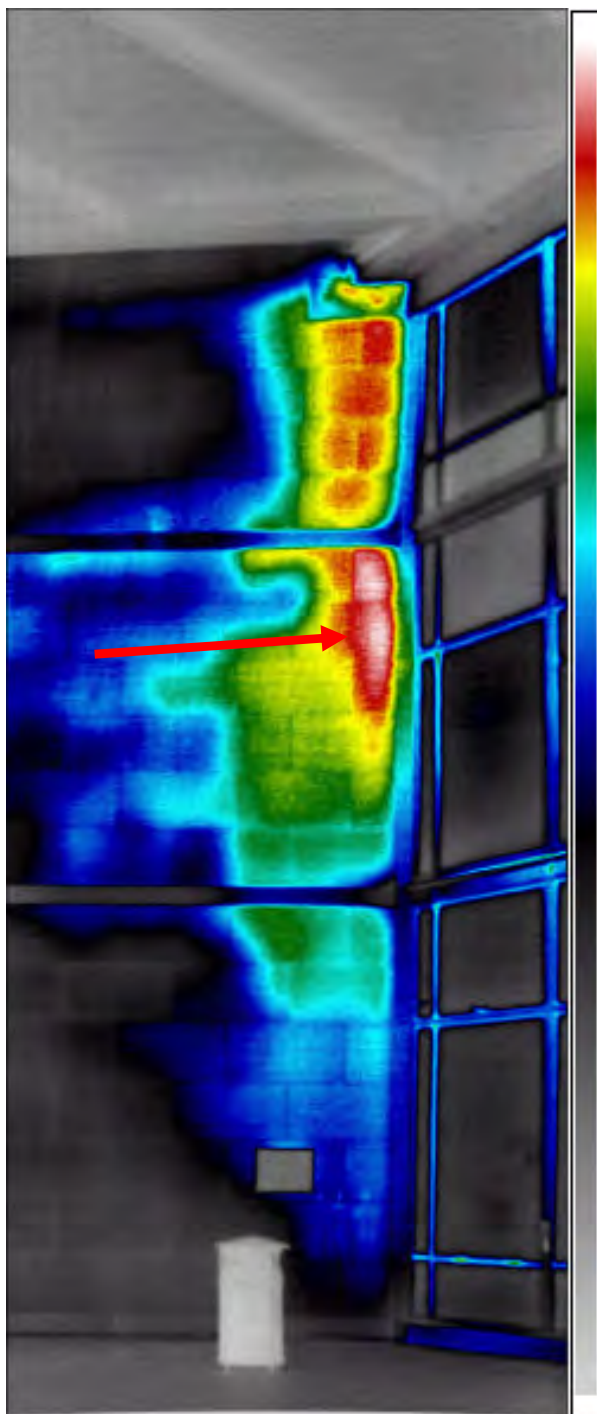
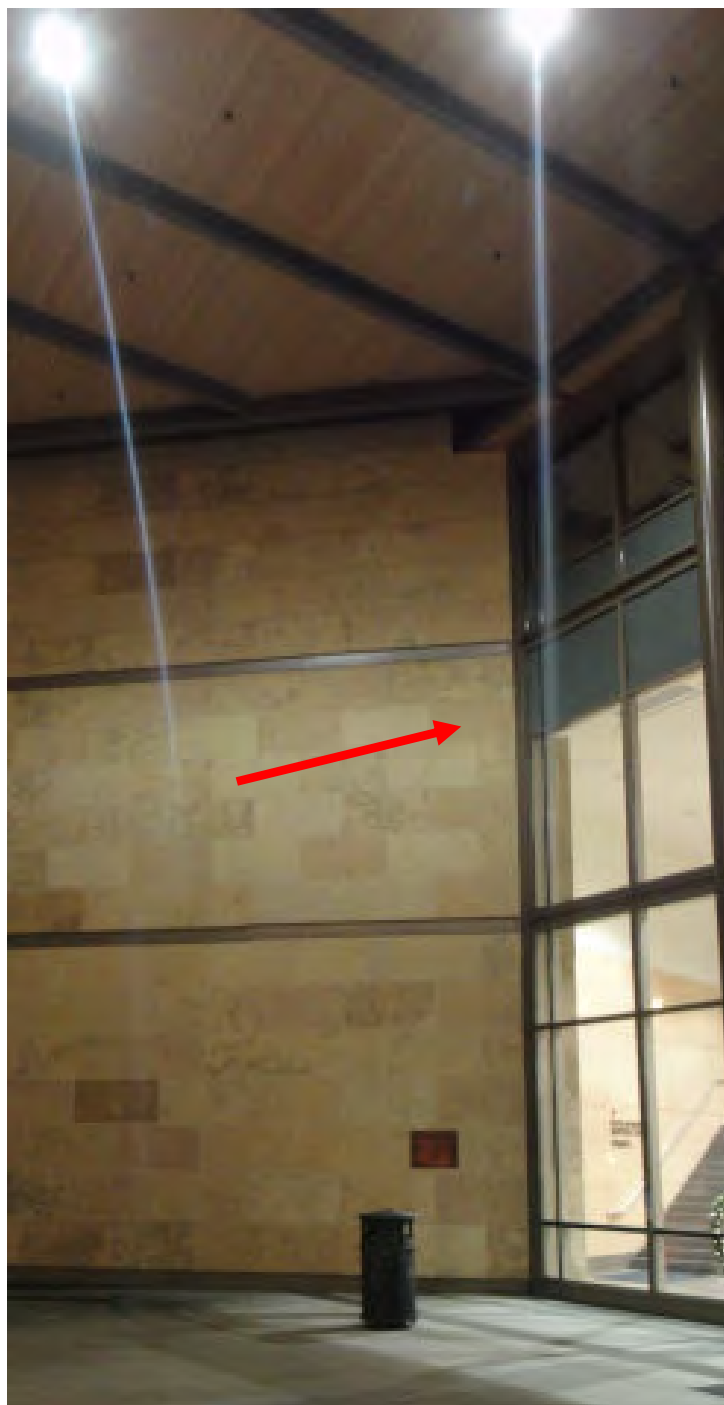
1<sup>st</sup> Floor east main entrance.

Unusual thermal bridging in the wall next to the glass entrance in the front of the building.

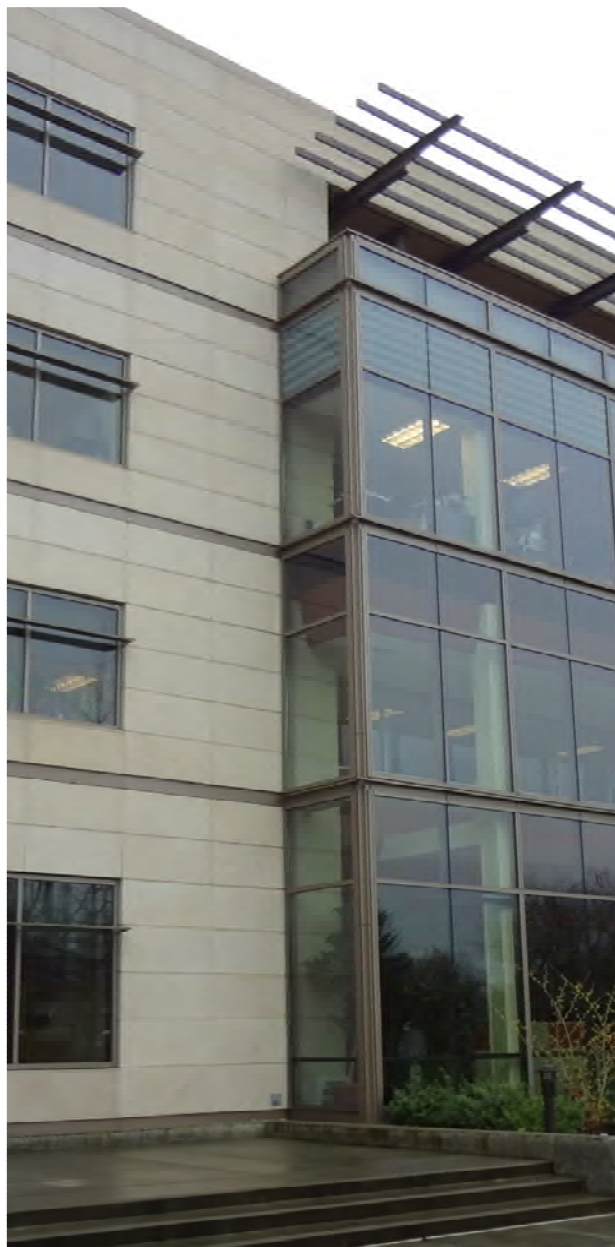
North side, East wall seam.

Thermal bridging along the seam of the building as the wall protrudes outward.

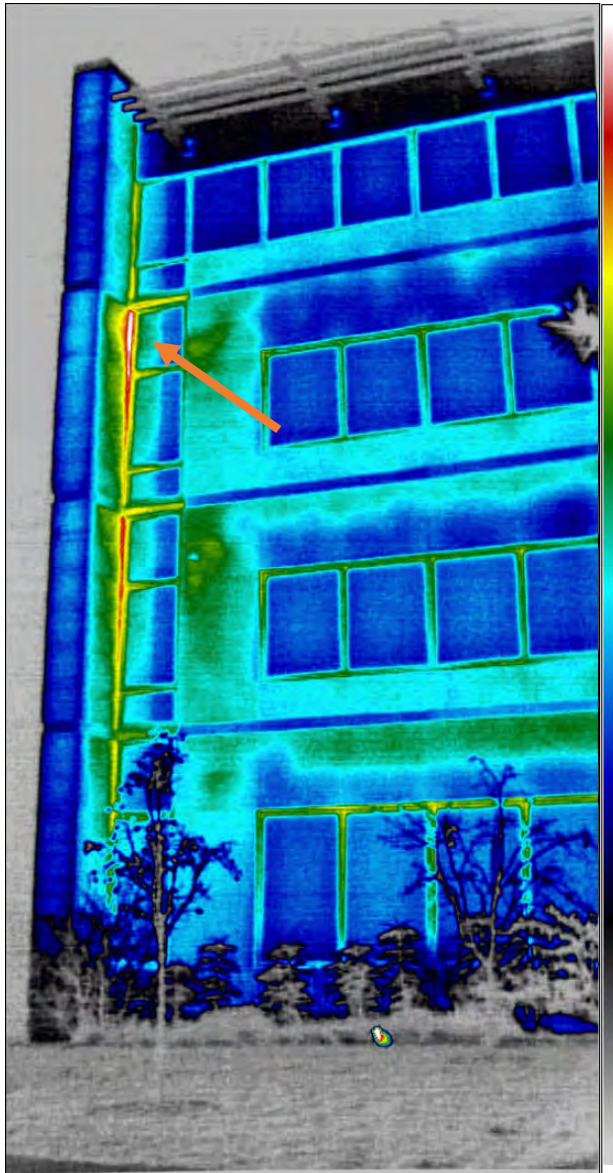
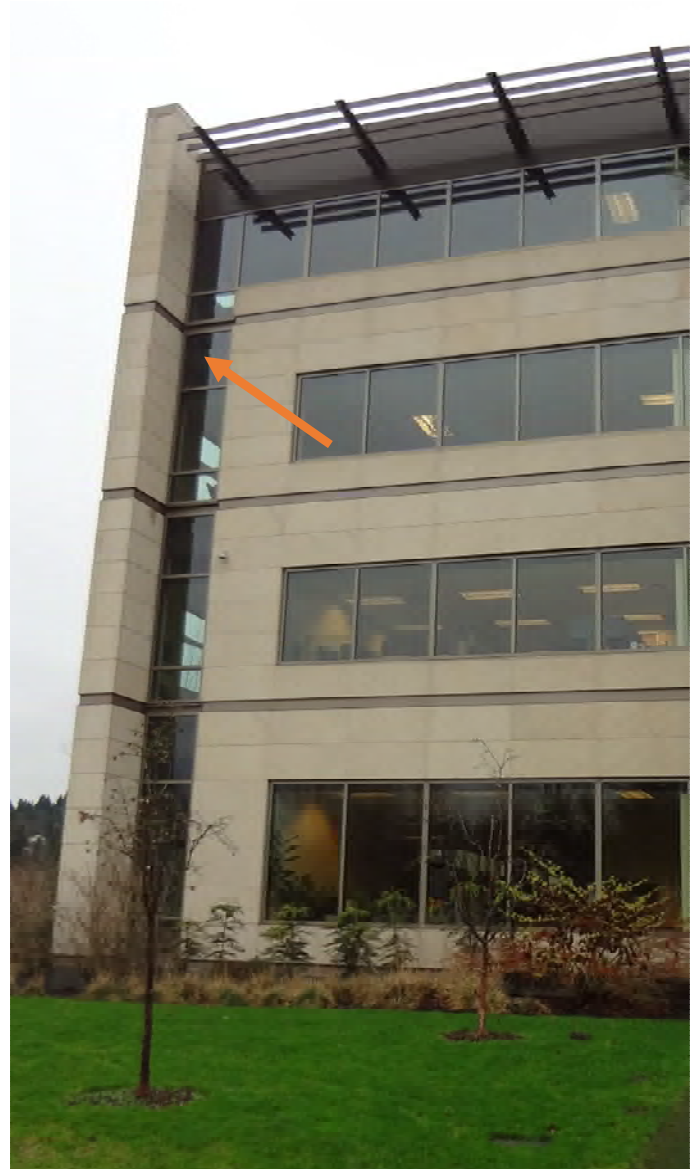
The red arrow shows the region of the most concentrated thermal bridging occurring between the wing wall and the 3rd floor windows.

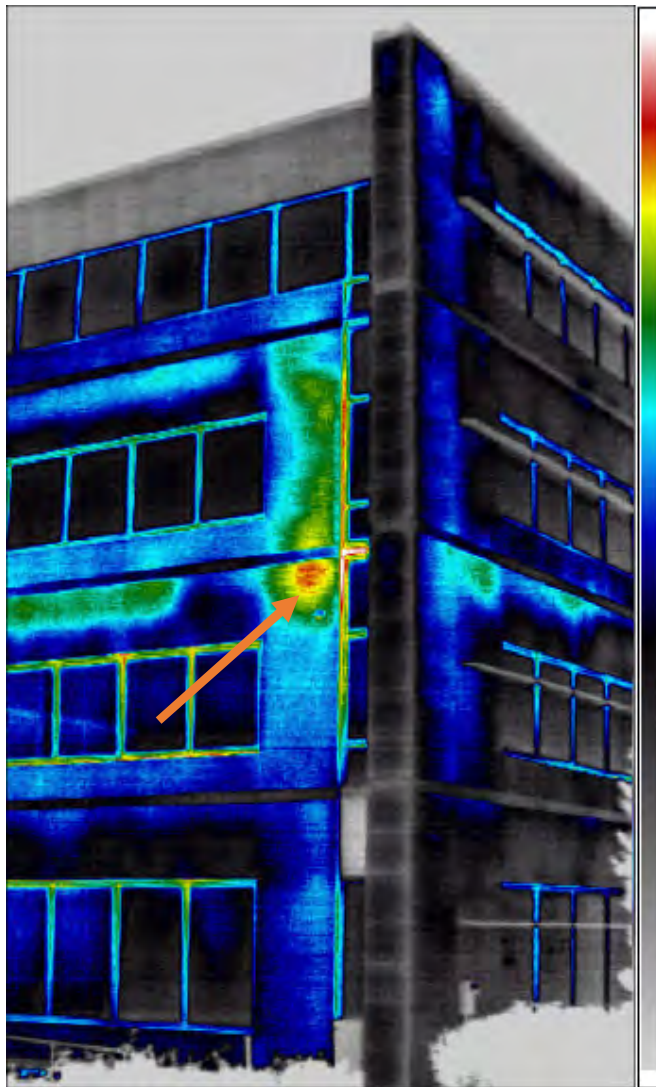
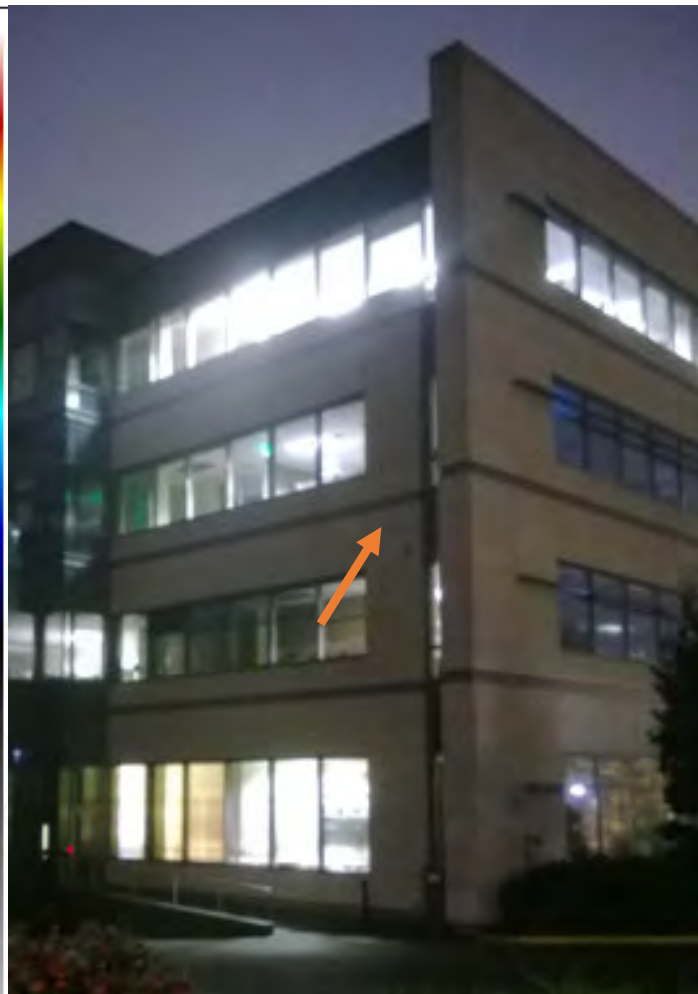
West side, southwest building exterior.

Thermal bridging at the intersection of the second and third floors and the wing wall.

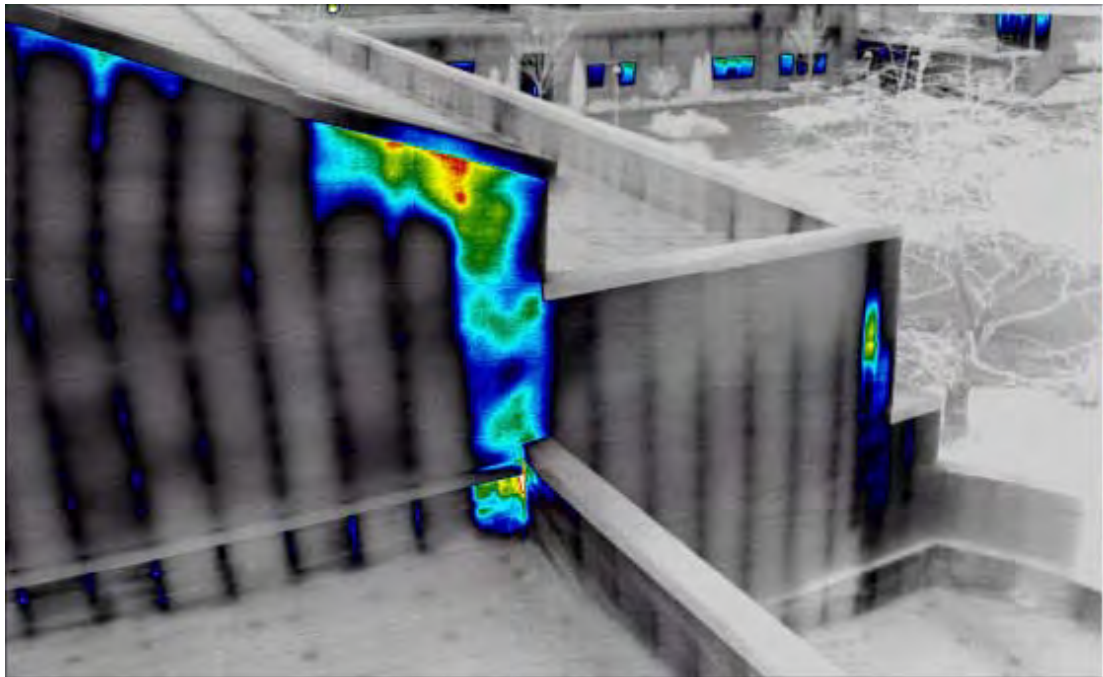
West end over front entrance.

Thermal bridging on the north end, east side of the peaked metal roof section.

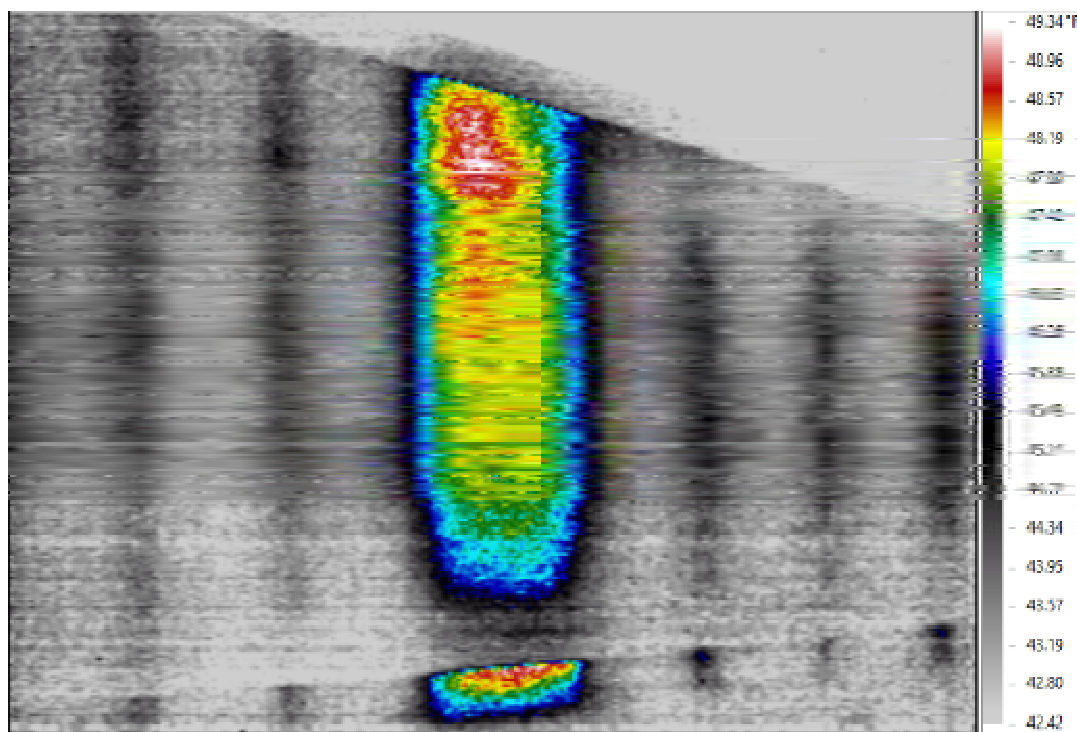
West end over front entrance.

Thermal bridging located on the west end of the wall.

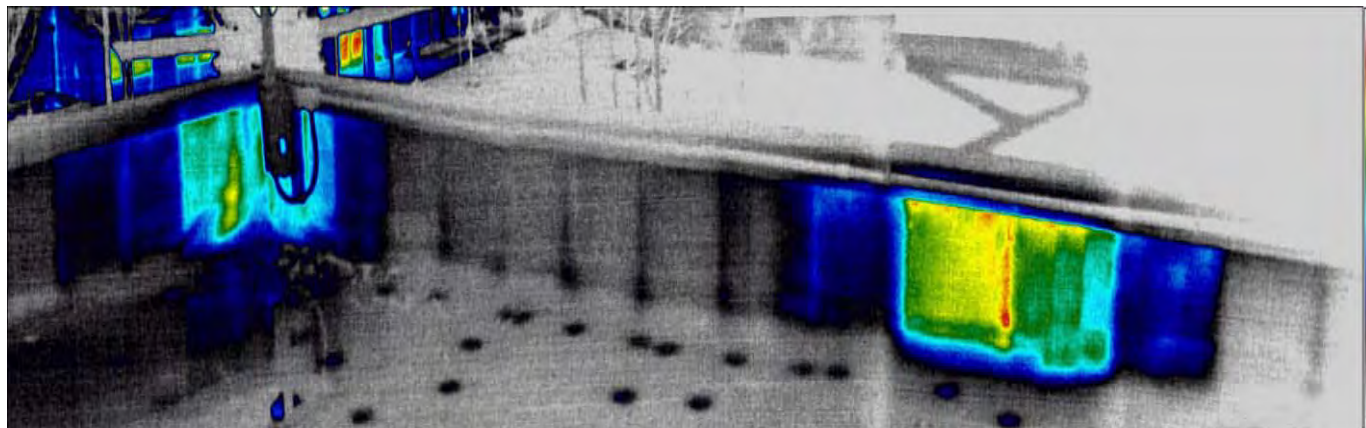
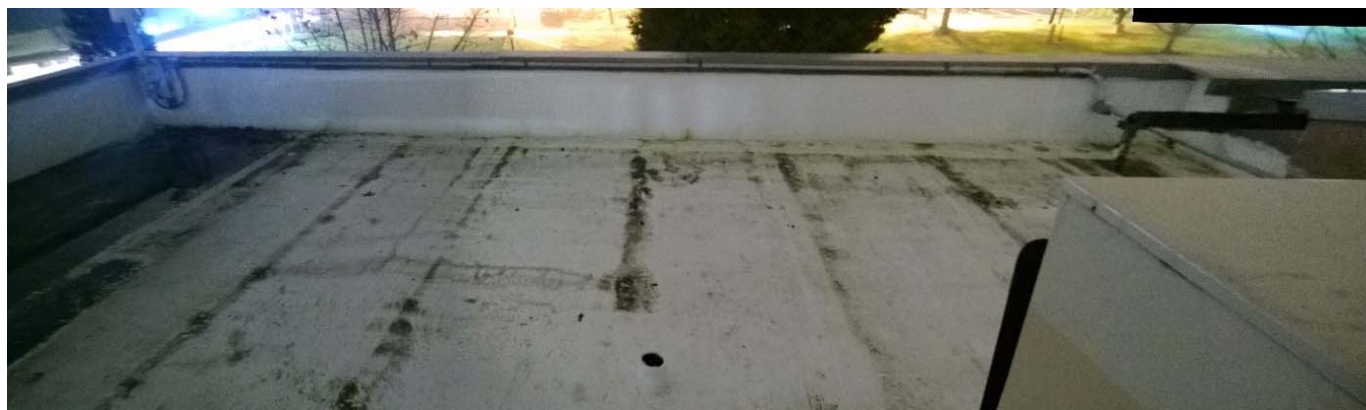
East end of the building rooftop.

Thermal bridging found along the southeast corner of the roof parapet.

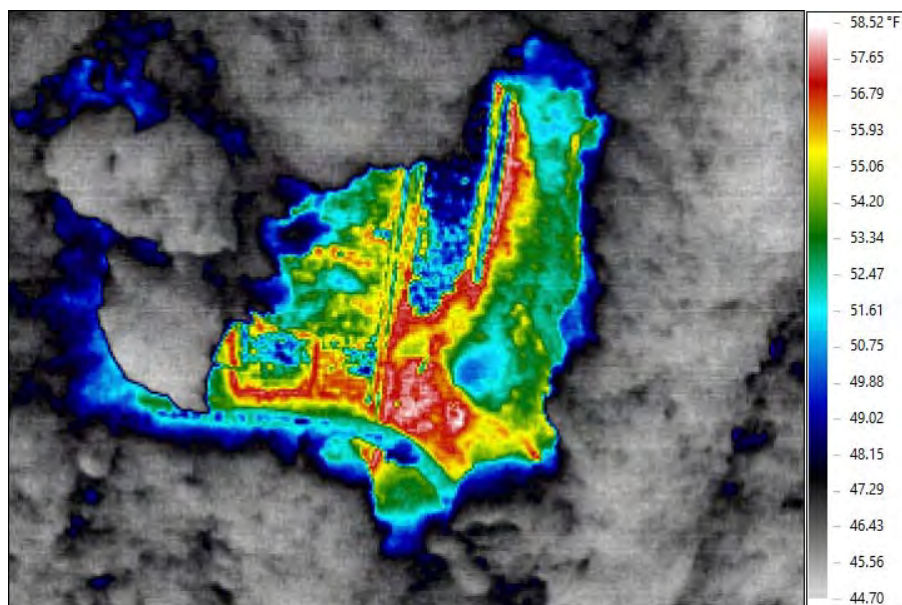
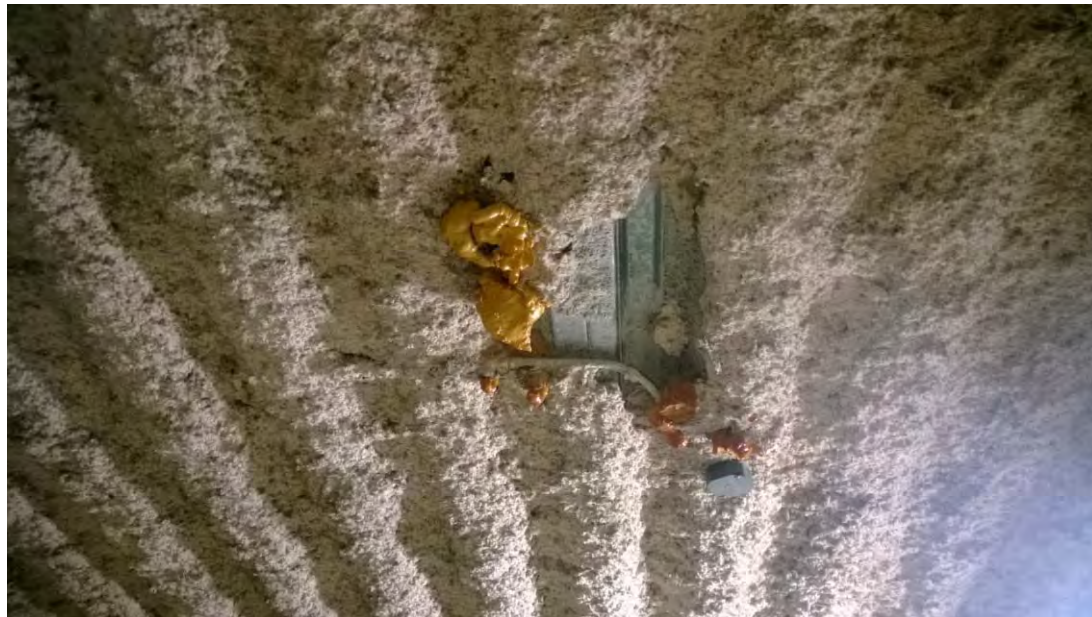
Underground parking garage, the ceiling near the white gate.

Numerous thermal observations in locations where the insulation is missing from the ceiling.

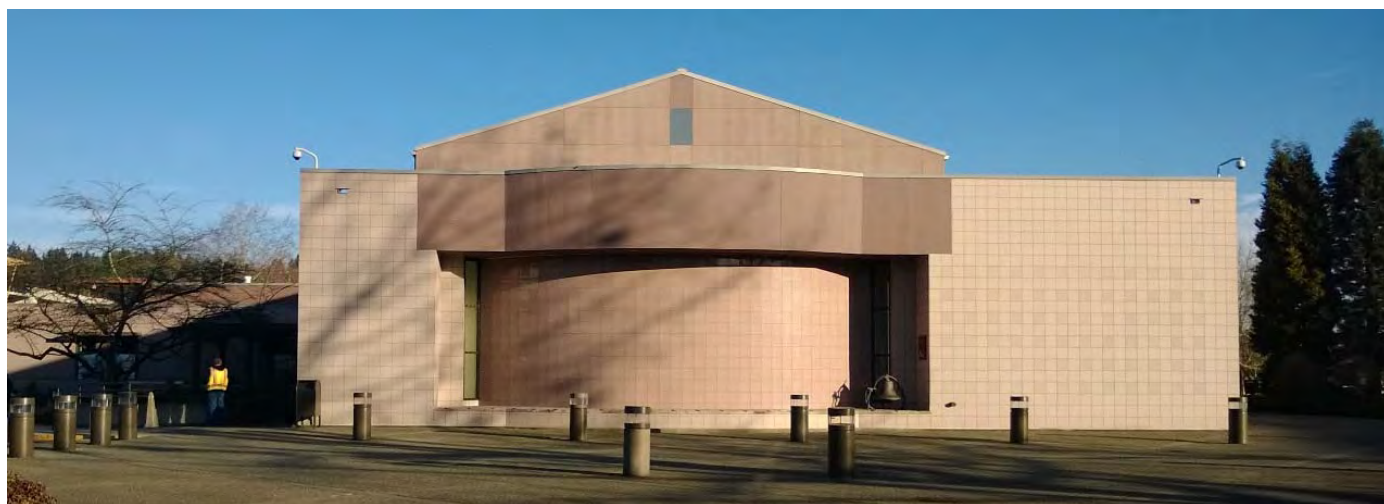
Thermal bridging in the overhead wall section on the far west side of the building.

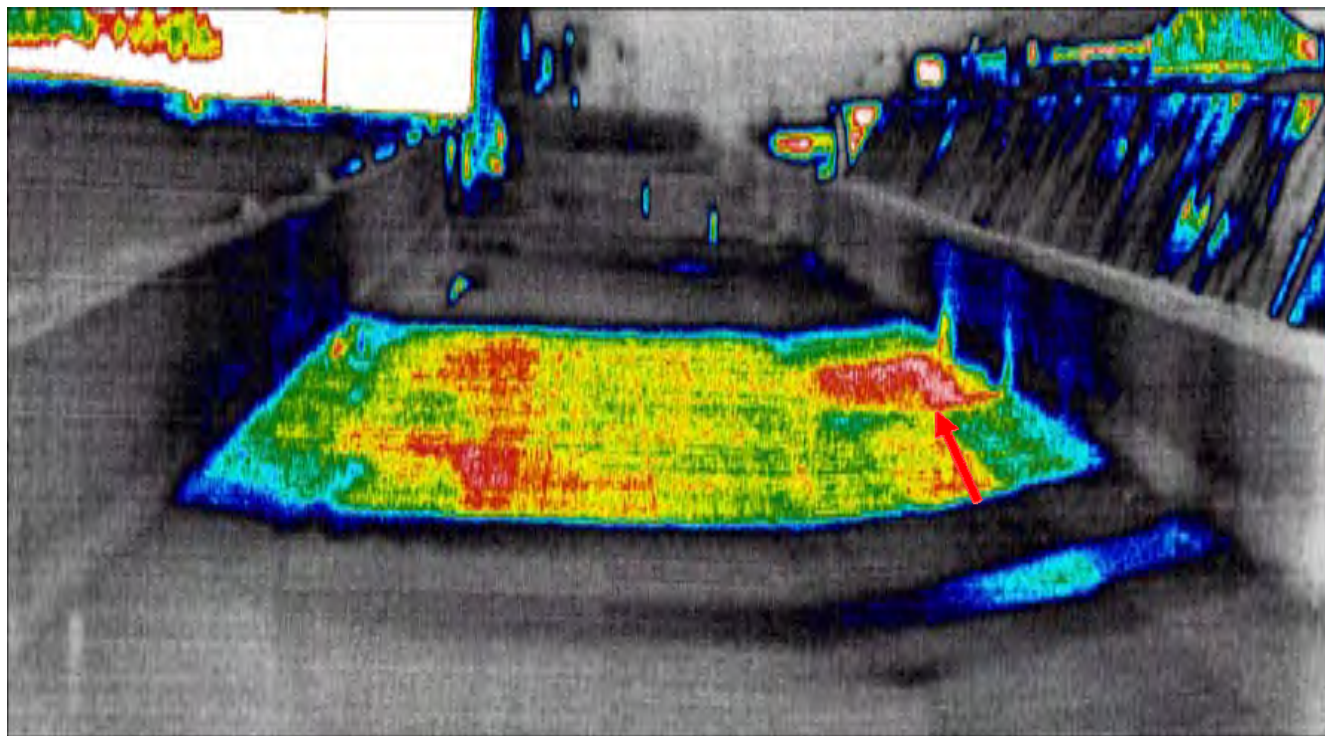
Typical thermal signature of wet insulation within the built up roof system. This image is looking east from the edge of the roof.

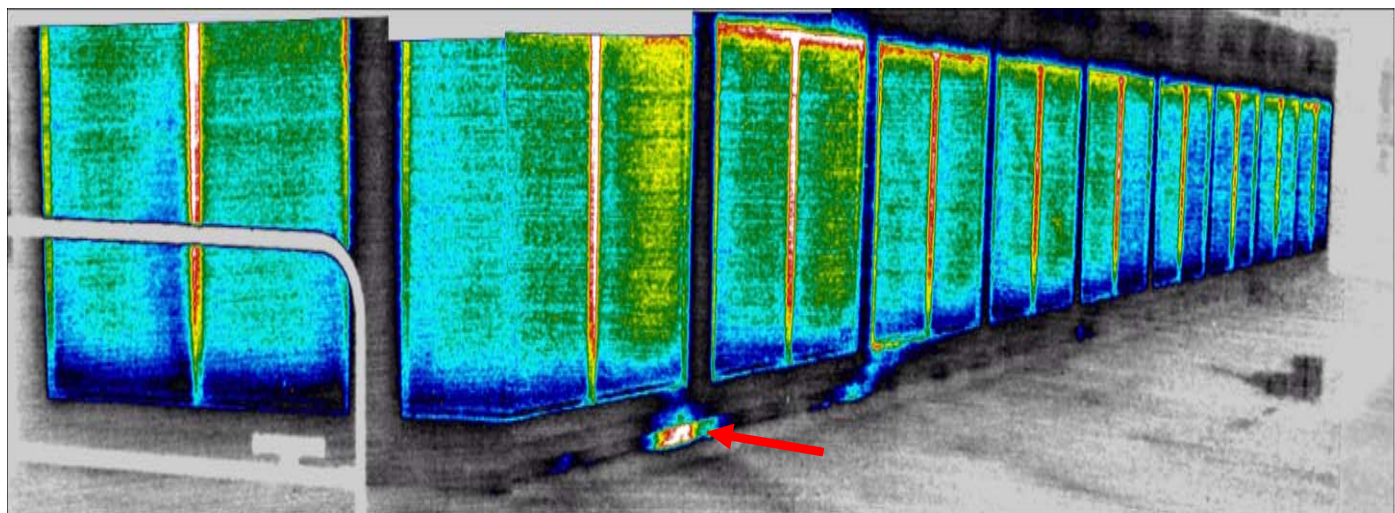
Heating occasionally along the base of the skylight windows.
