**CITY OF REDMOND**  
**FACILITY CONDITION ASSESSMENT**  
**15 MARCH 2014**

## **I. EXECUTIVE SUMMARY**

### **1.1 Introduction**

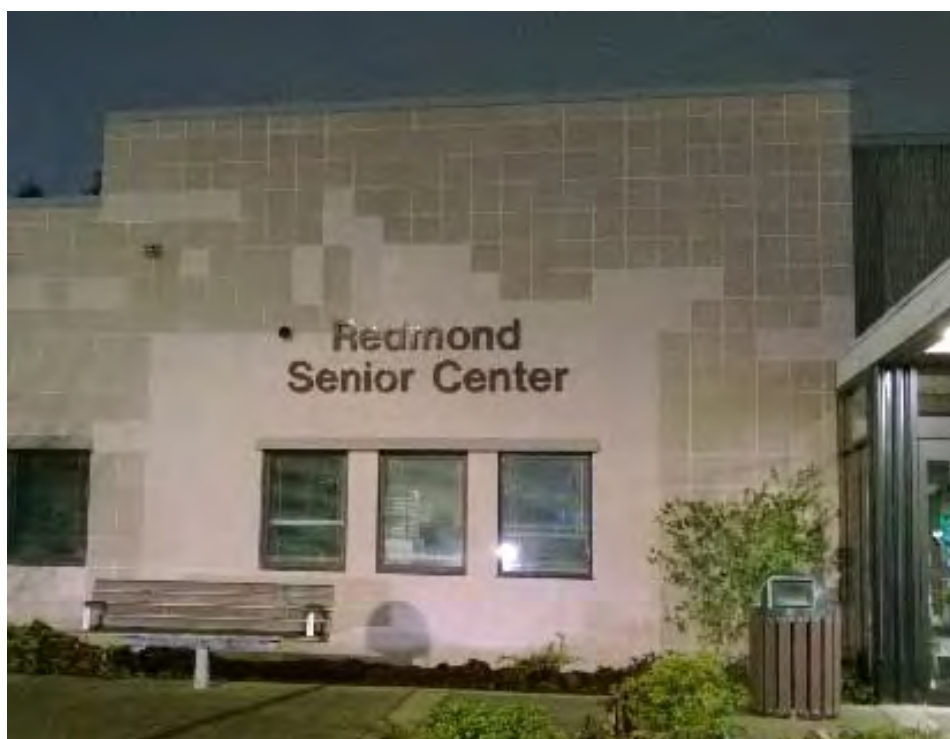
Thermal bridging through the east wall shows a random pattern above the windows.

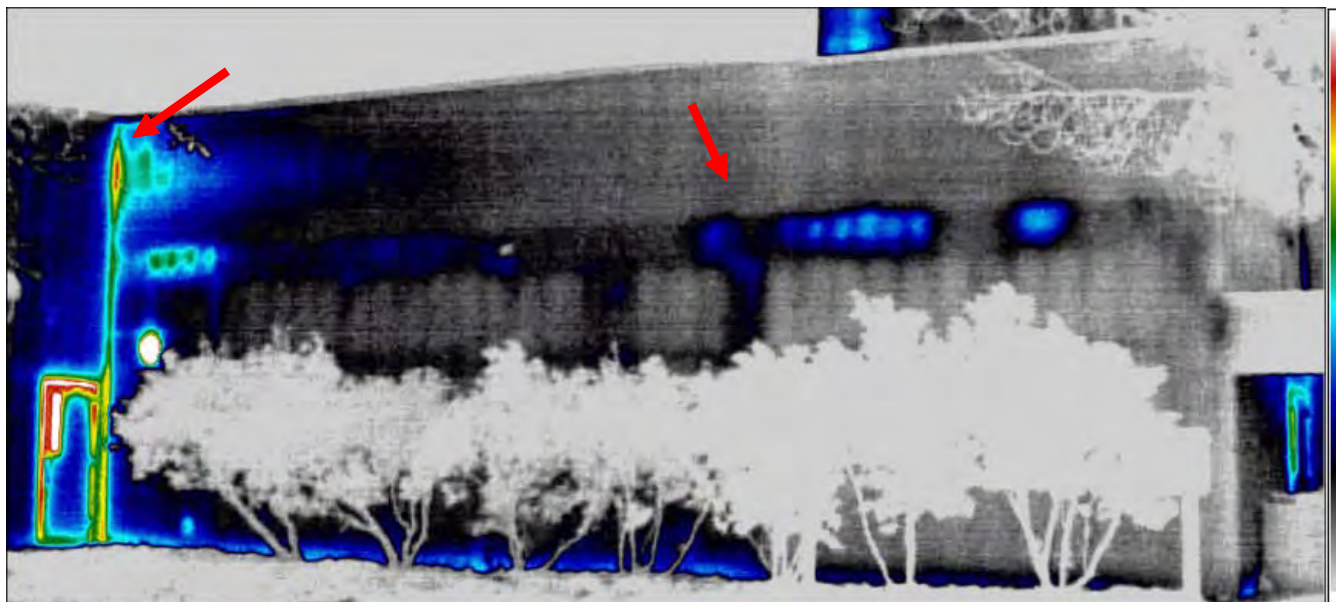
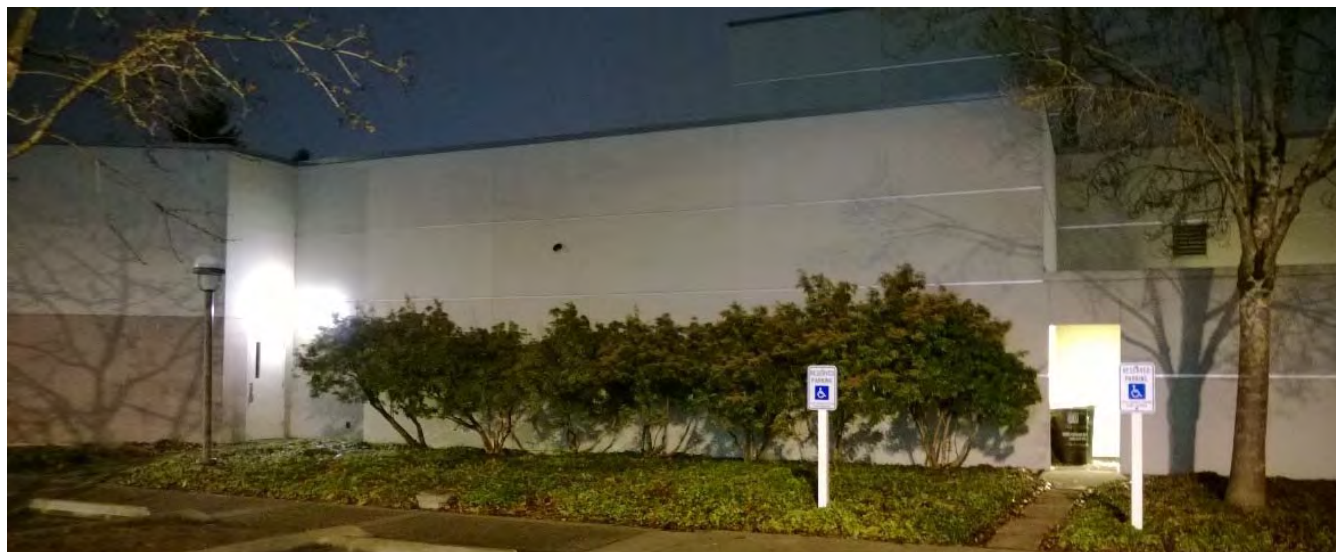
Thermal bridging along the seam of the two walls intersecting above the doorway.
