**CITY OF REDMOND**  
**FACILITY CONDITION ASSESSMENT**  
**15 MARCH 2014**

## **I. EXECUTIVE SUMMARY**

### **1.1 Introduction**

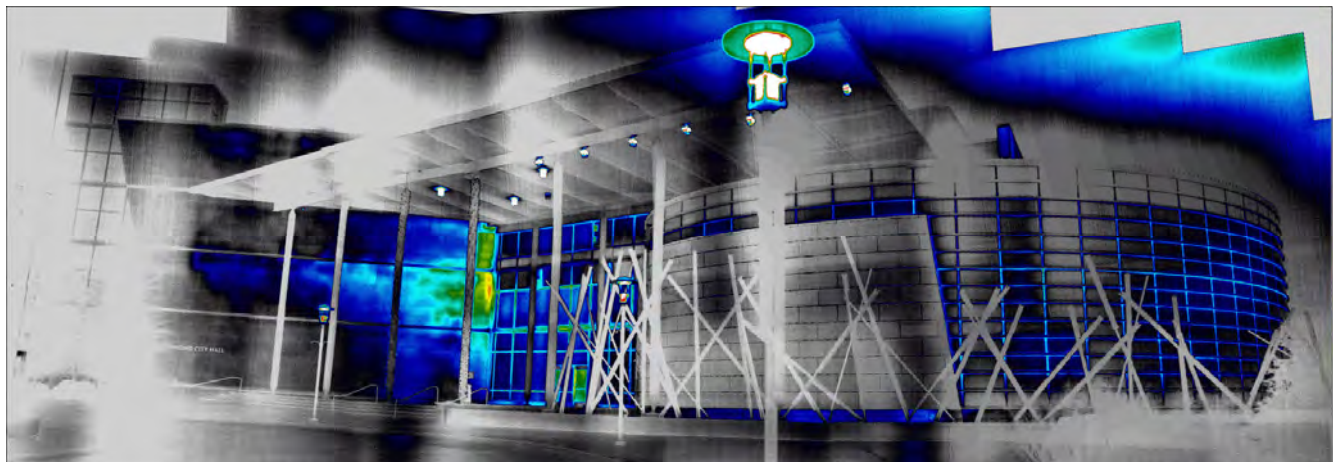
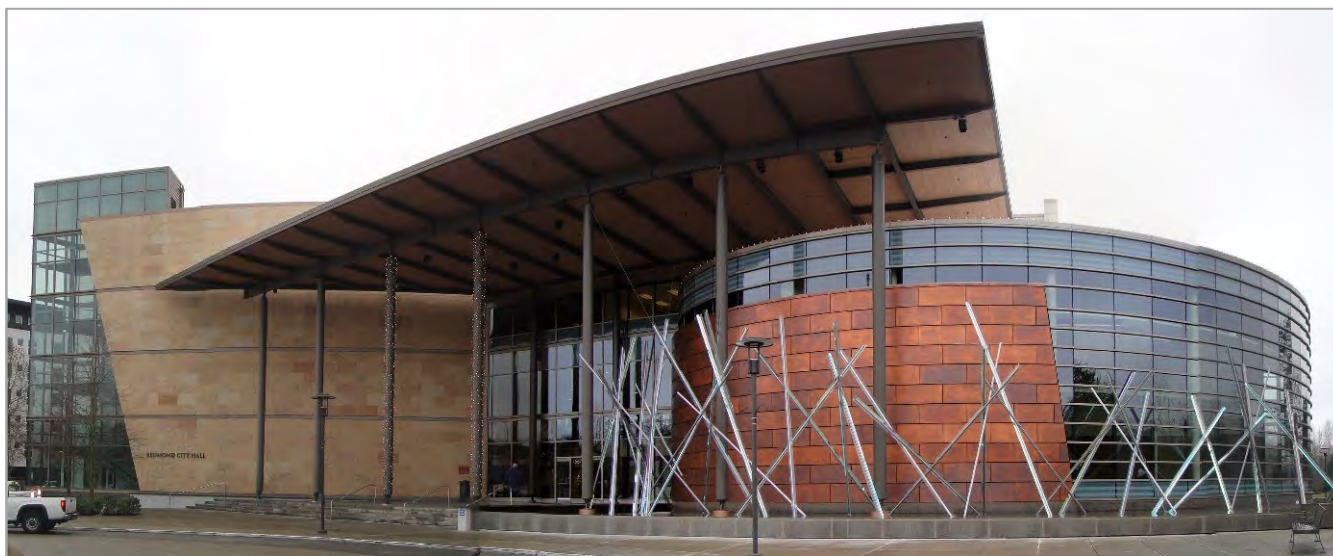
3<sup>rd</sup> Floor, roof level above main entrance

Heat escaping around the window/door seal for the south window that is used as a access point to the outside roof level.

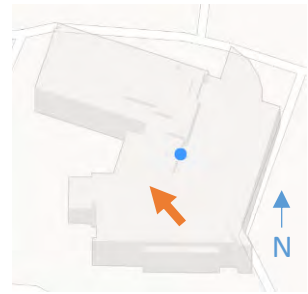
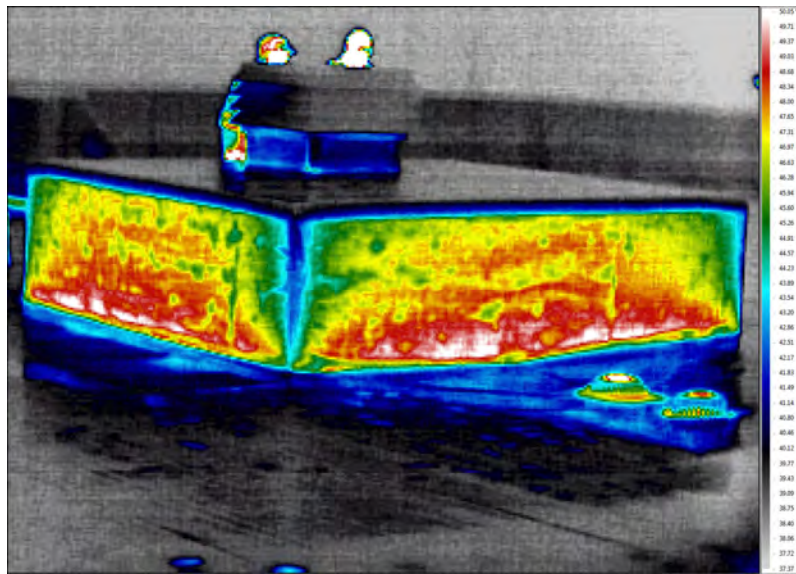
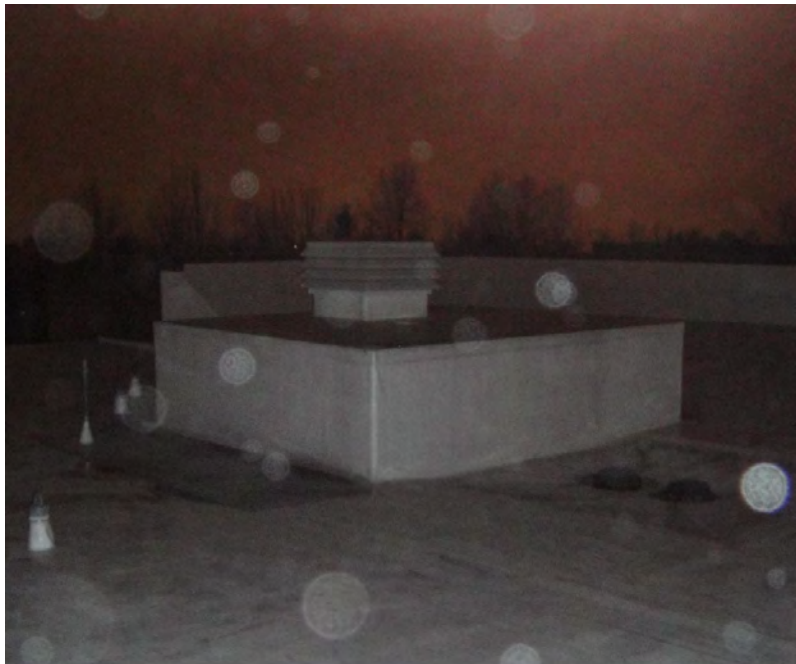
4<sup>th</sup> Floor Roof, Fright Elevator Shaft,  
Southeast corner of cap.

Thermal bridging though the walls of the elevator shaft.

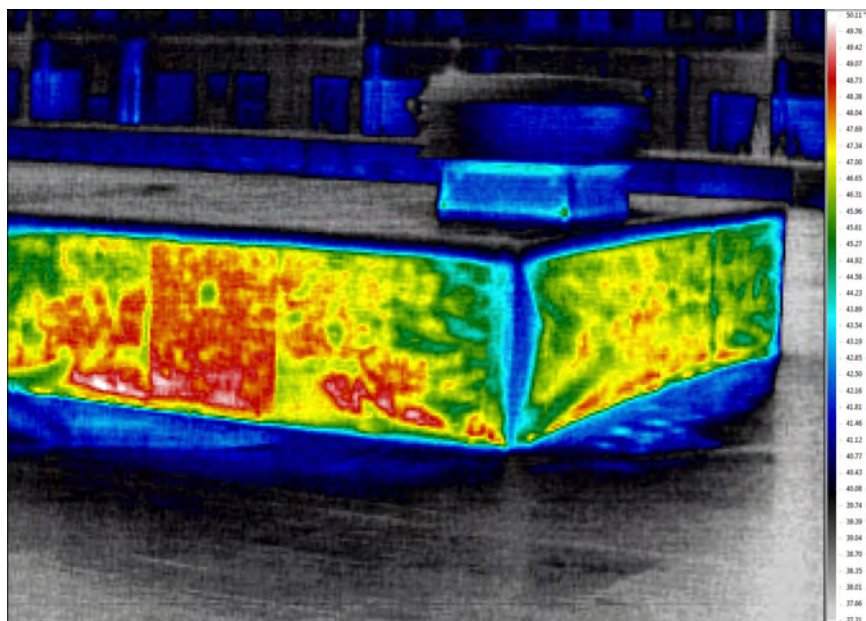
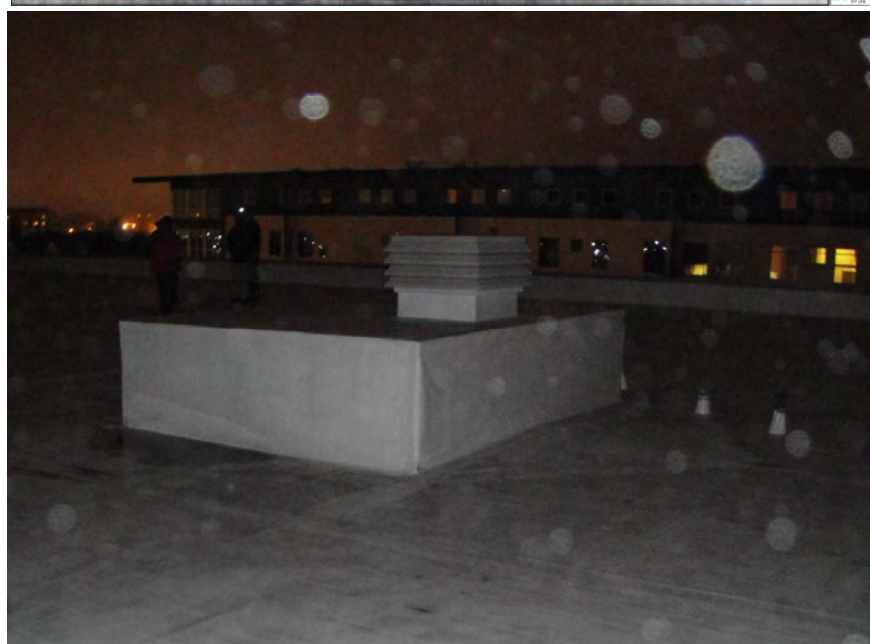
## 4<sup>th</sup> Floor Roof, Fright Elevator Shaft, Northwest corner of cap.

Thermal bridging though the walls of the elevator shaft.

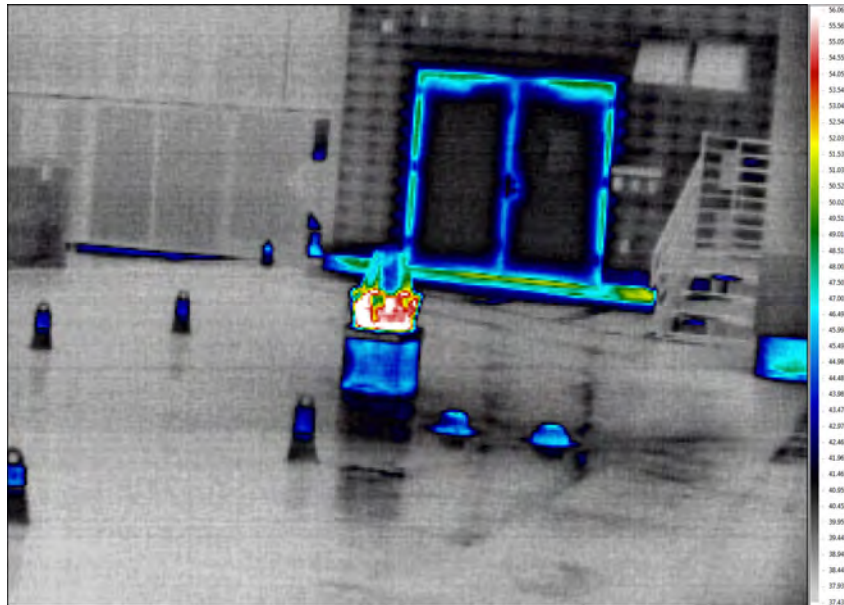
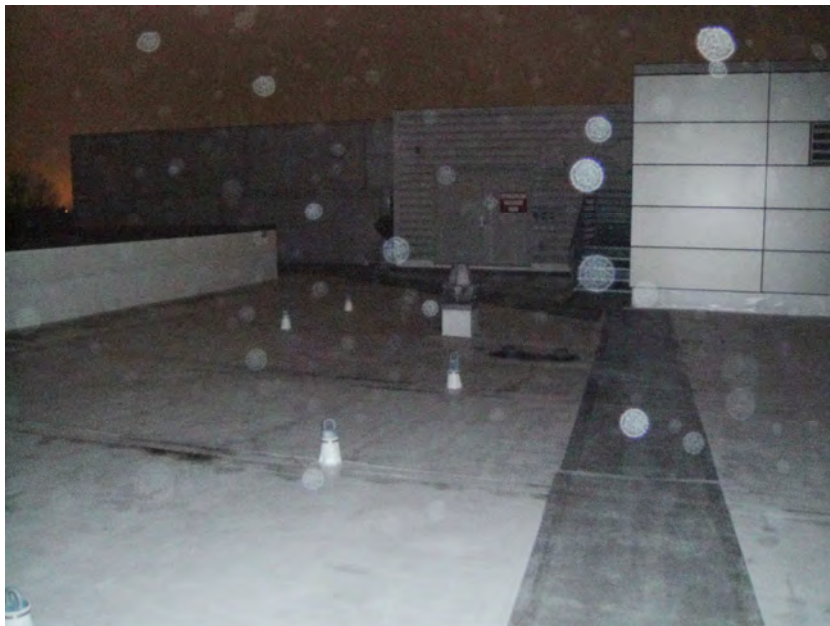
4<sup>th</sup> Floor rooftop, and door entryway.

Heat escaping around the edge of the door frame for the mechanical room.

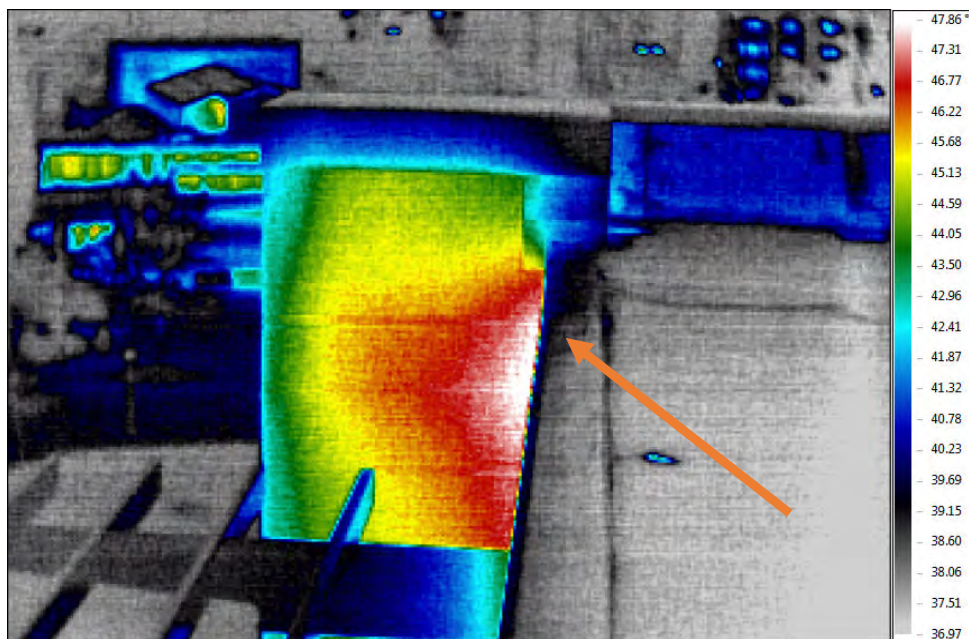
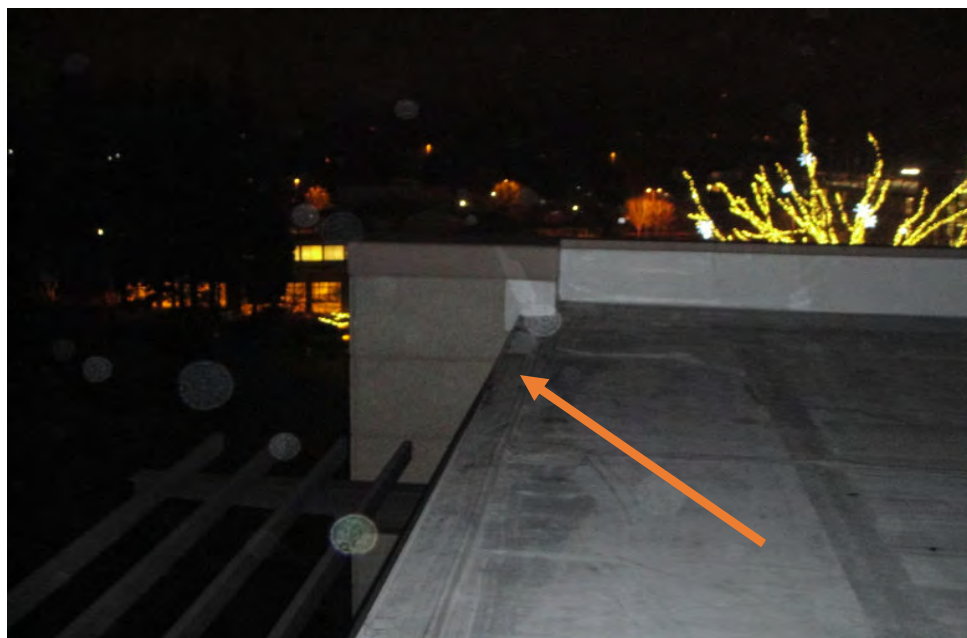
4<sup>th</sup> Floor Roof level, Northwest corner architectural wing.

Thermal bridging at intersection of roof and wing wall

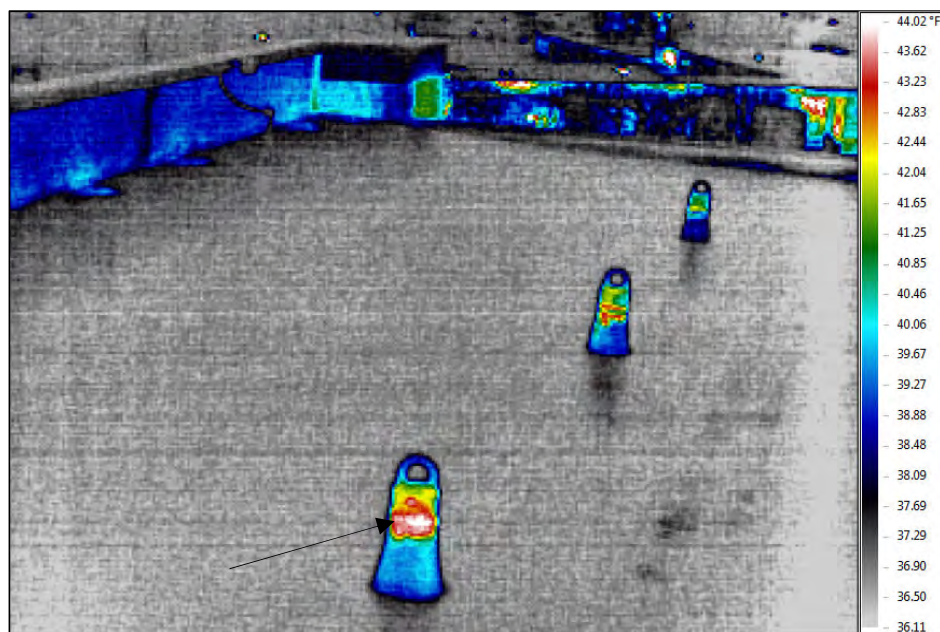
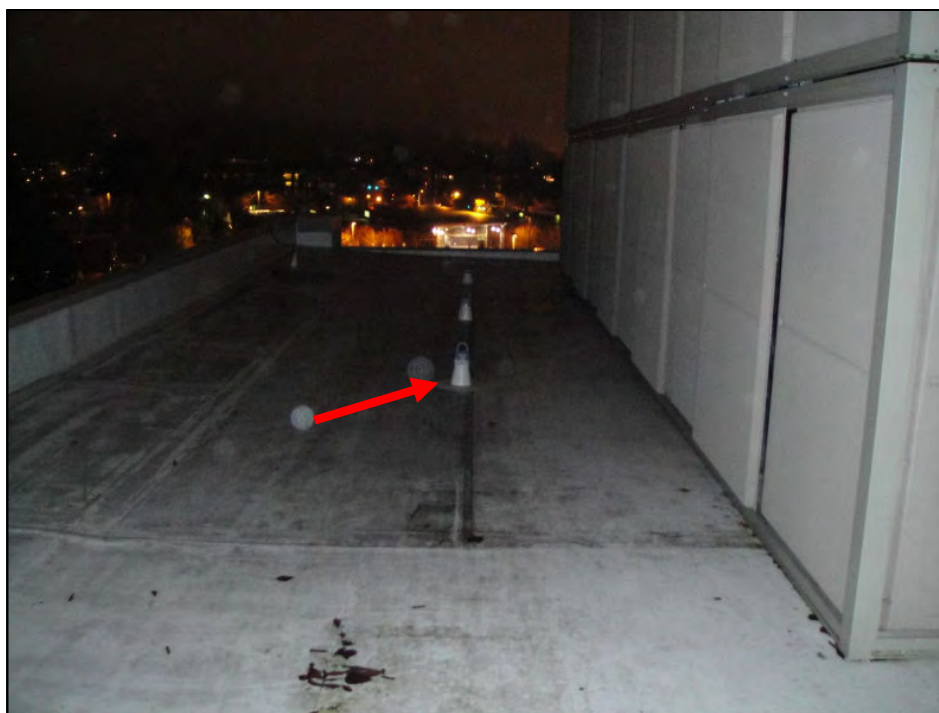
## 4<sup>th</sup> Floor Roof, Northeast corner.

Thermal bridging from fall protection footings.

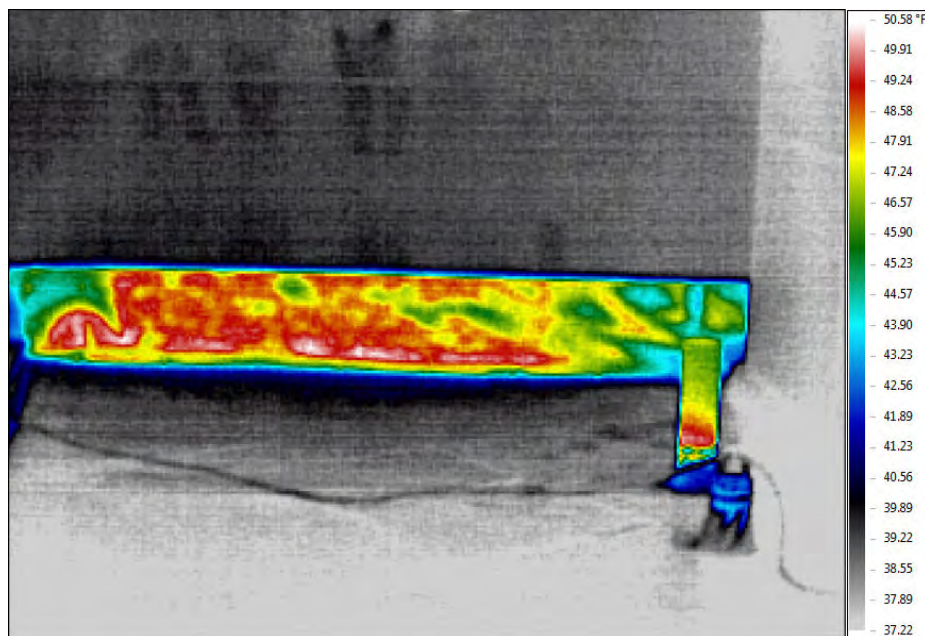
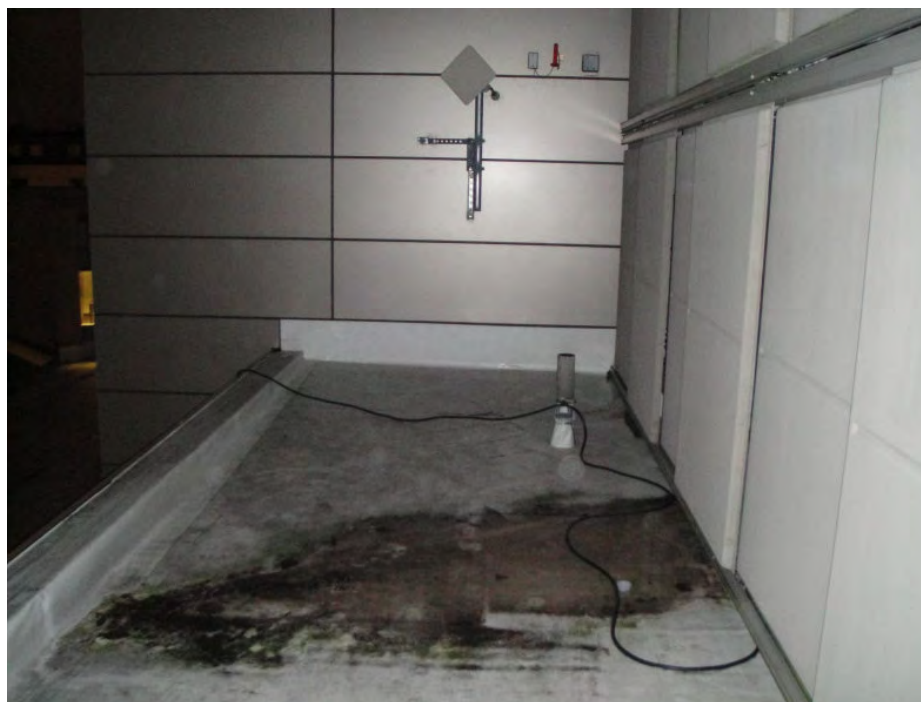
4<sup>th</sup> Floor Roof, North wall of Mechanical penthouse.

North wall, thermal bridging at base of the wall

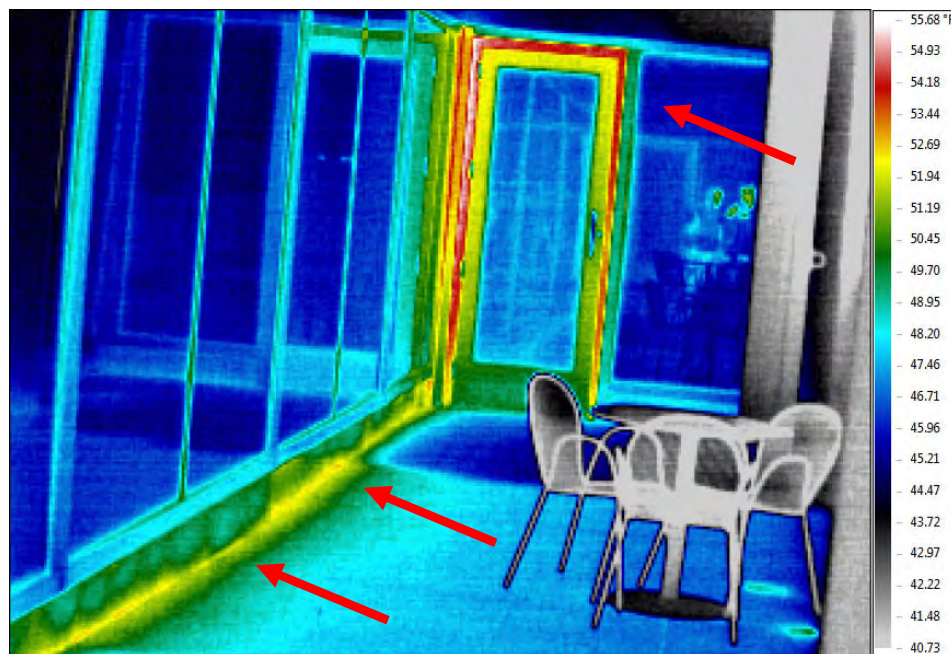
## 4<sup>th</sup> Floor, North Balcony

Heat escape from the West door frame and base of south wall

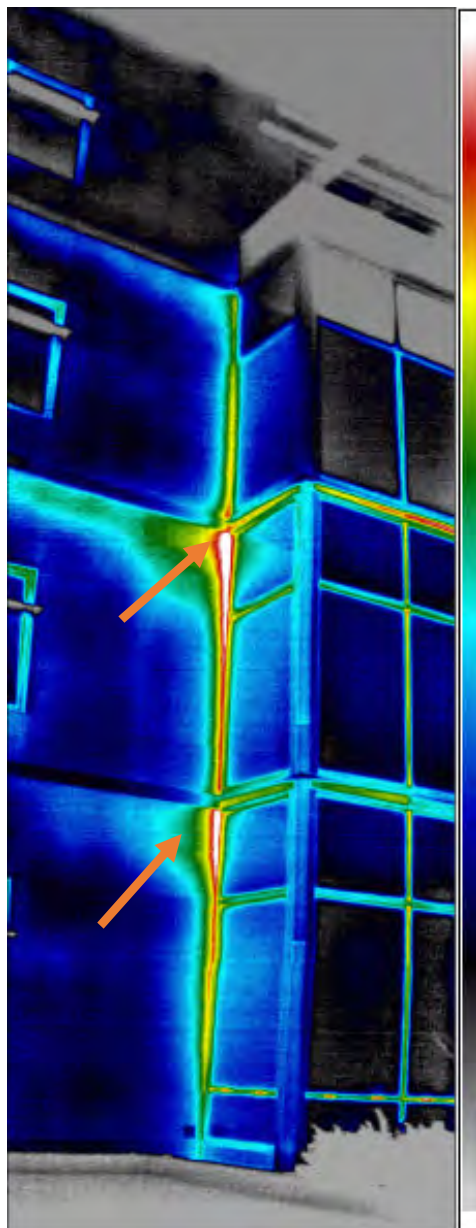
North side, East wall seam.

Thermal bridging along the seam of the building as the wall protrudes outward.

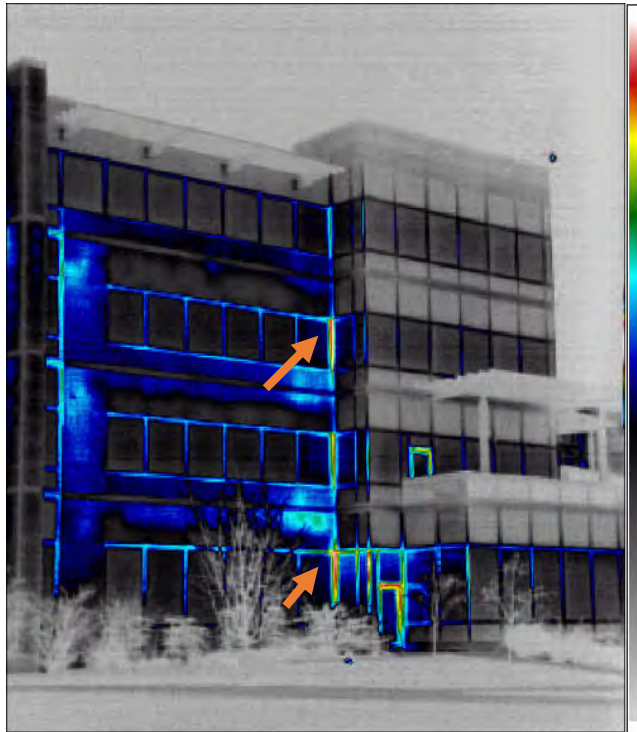
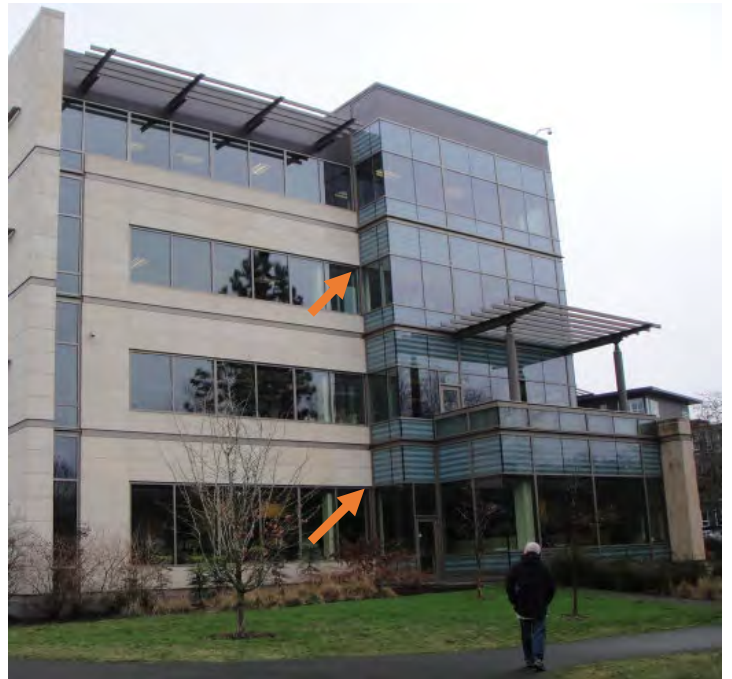
West side, North wing building exterior.

1<sup>st</sup> and 3<sup>rd</sup> floor heat loss around the window flashing at the intersection of the south wall and the glass exterior.

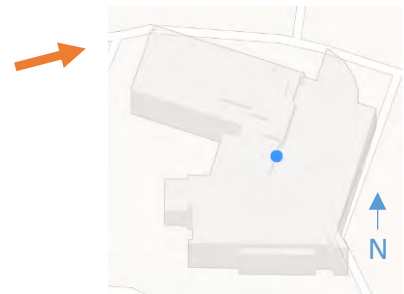
The red arrow shows the region of the most concentrated thermal bridging occurring between the wing wall and the 3rd floor windows.

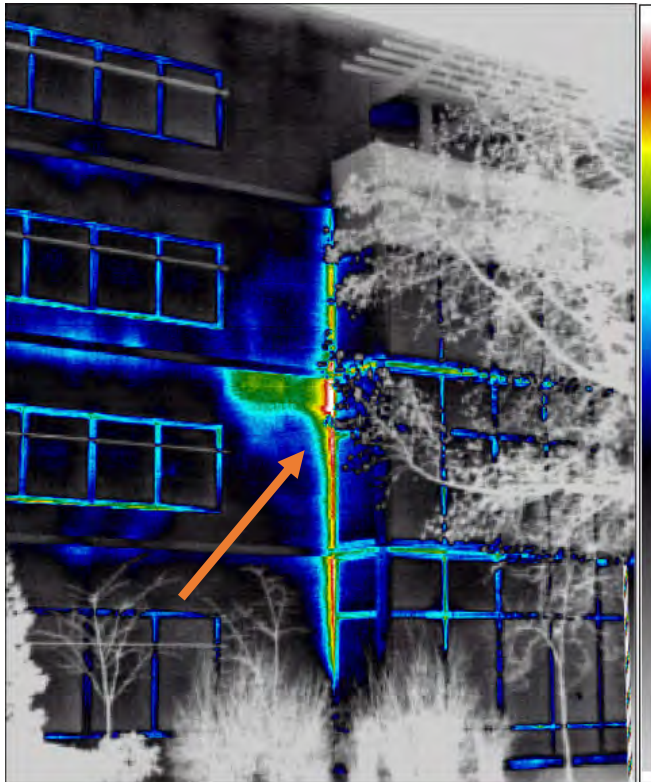
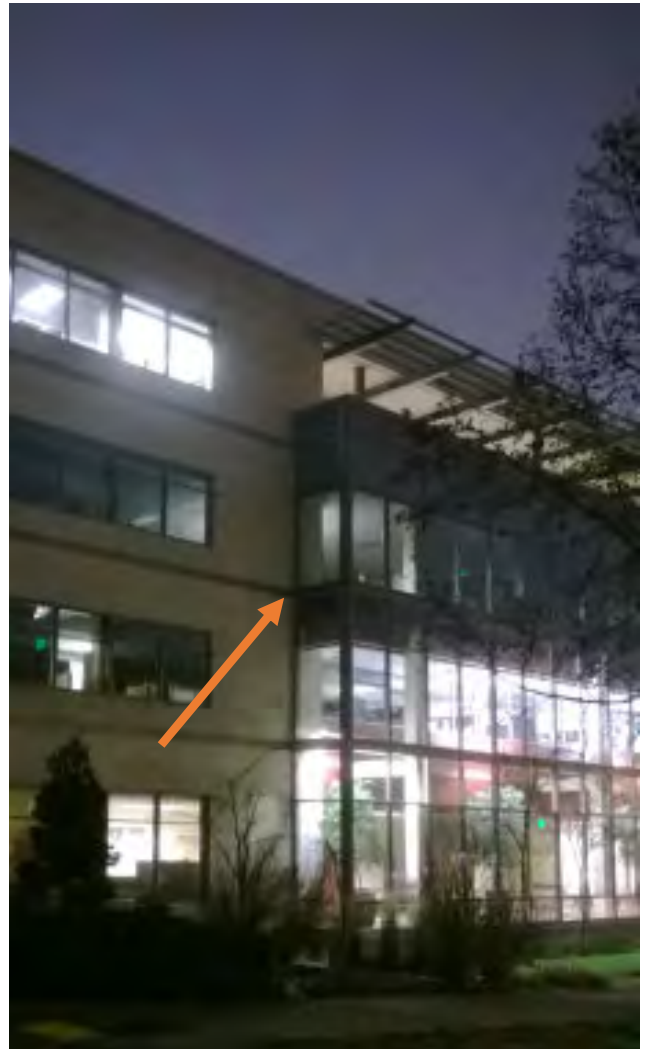
South side, West wall seam.

Thermal bridging at the intersection of the 2<sup>nd</sup> and 3<sup>rd</sup> floor where it meets the glass.

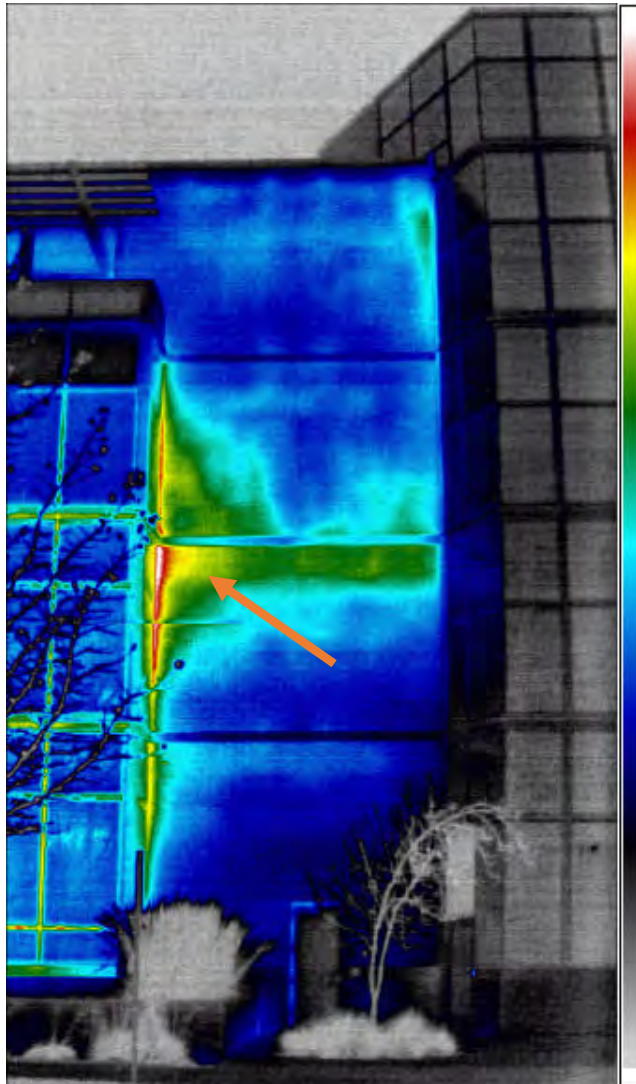
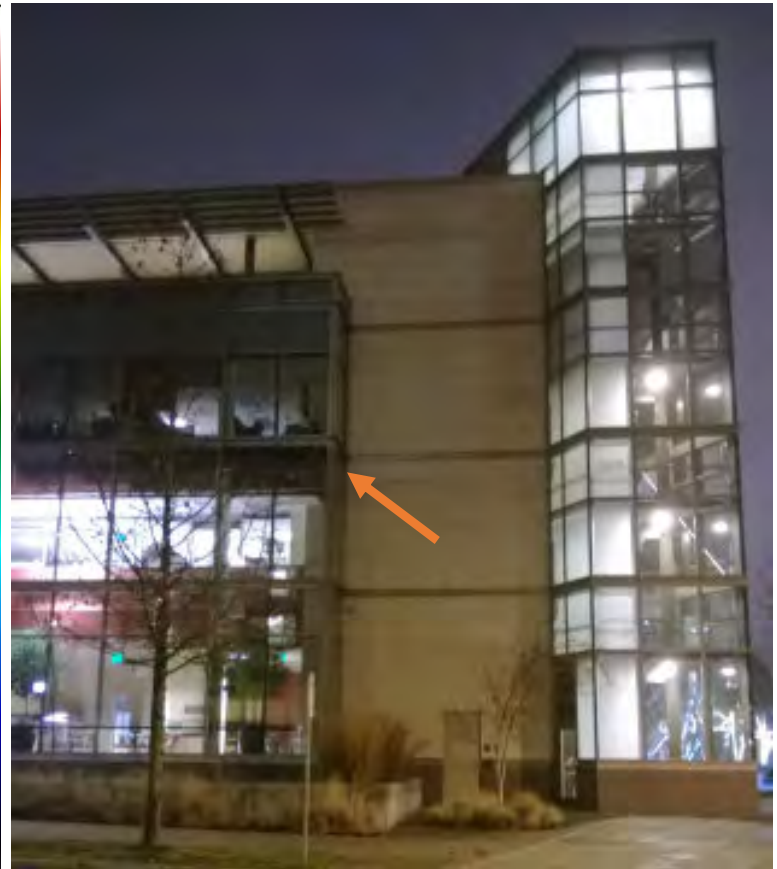
South side, East wall seam.

Thermal bridging at the intersection of the 2<sup>nd</sup> and 3<sup>rd</sup> floor where it meets the glass.

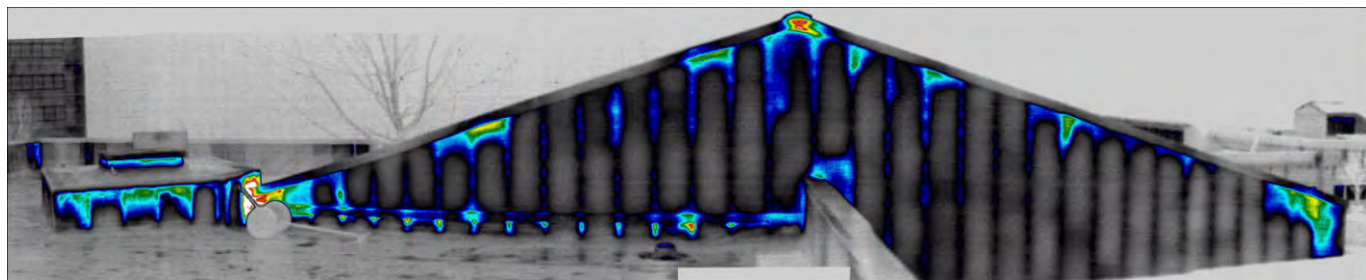
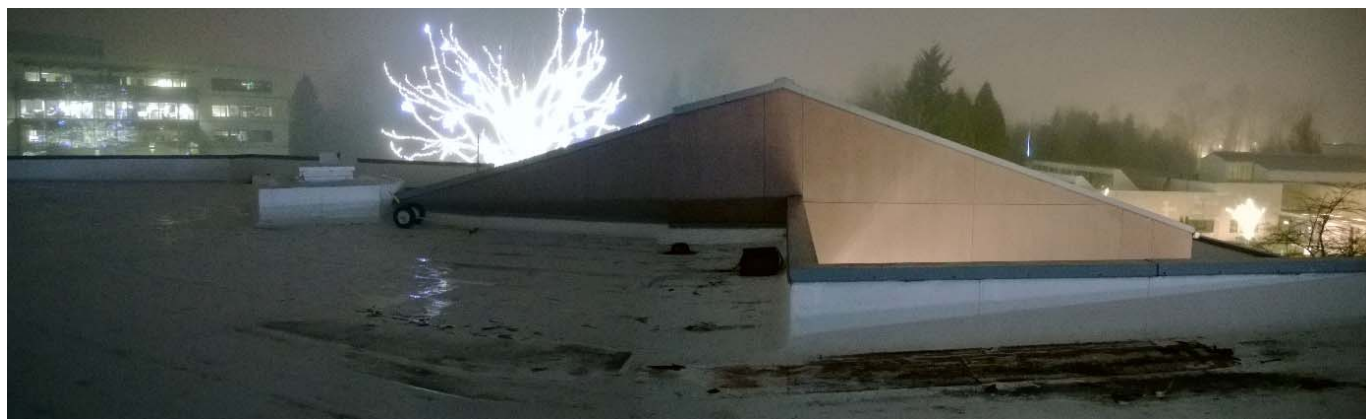
West end over entrance.

Thermal bridging spanning over various points the metal peaked roof.

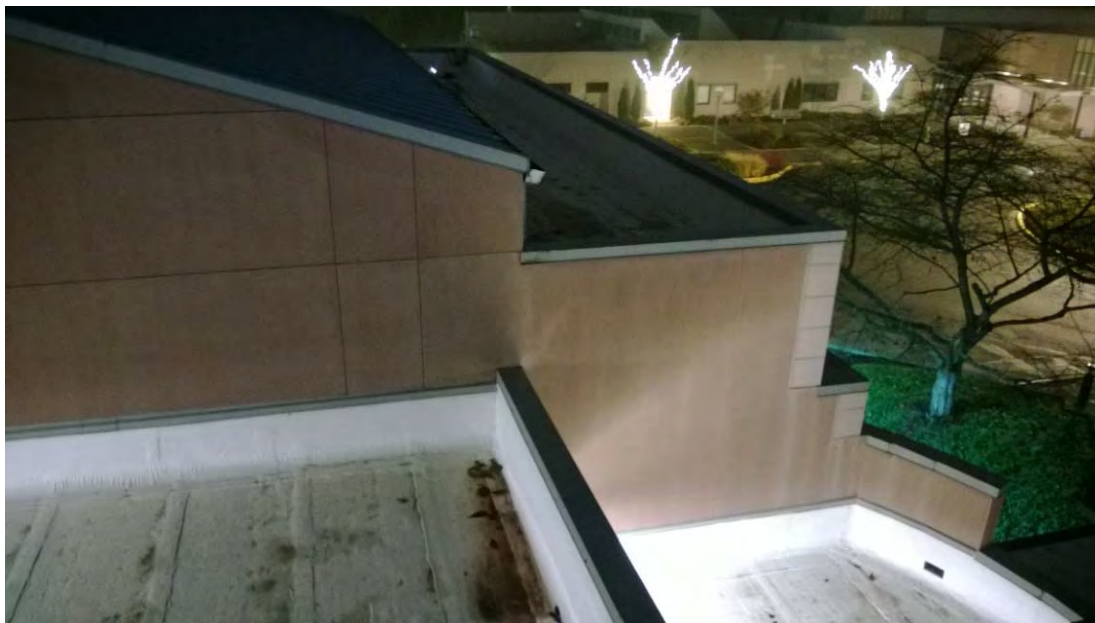
West end over front entrance.

Thermal bridging on the north end, east side of the peaked metal roof section.

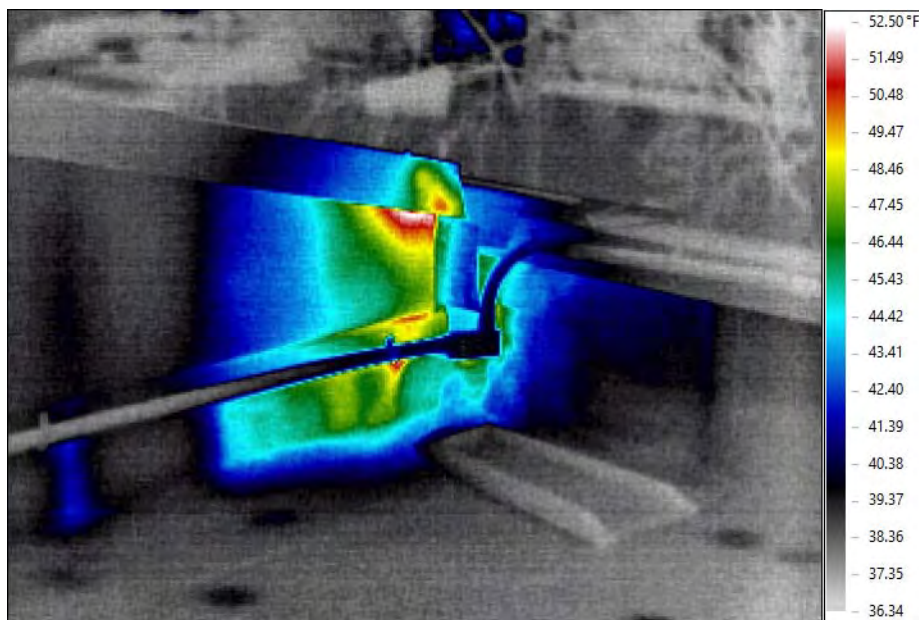
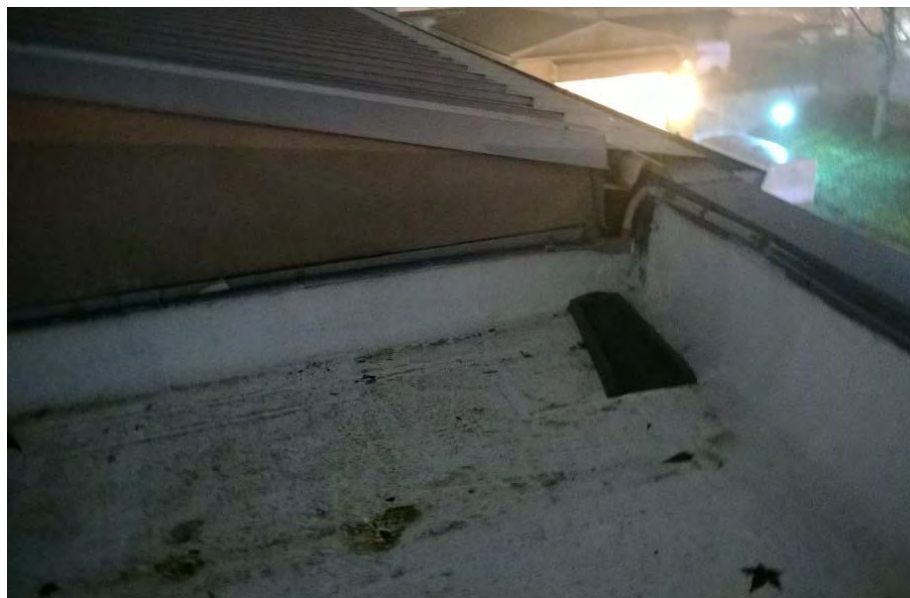
East end of the building rooftop.

Northeast corner of the roof, where the metal roof intersects with the gutter.

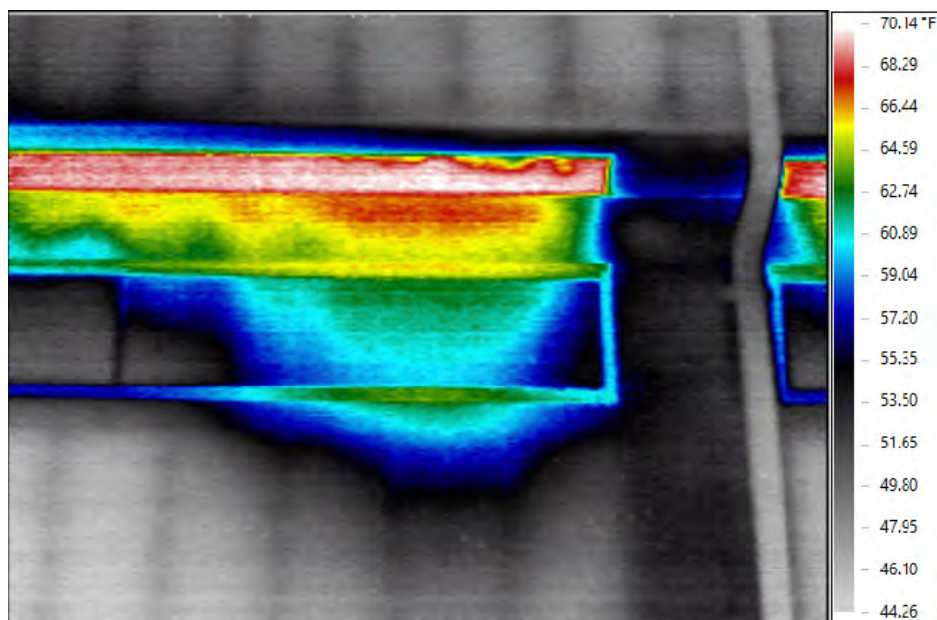
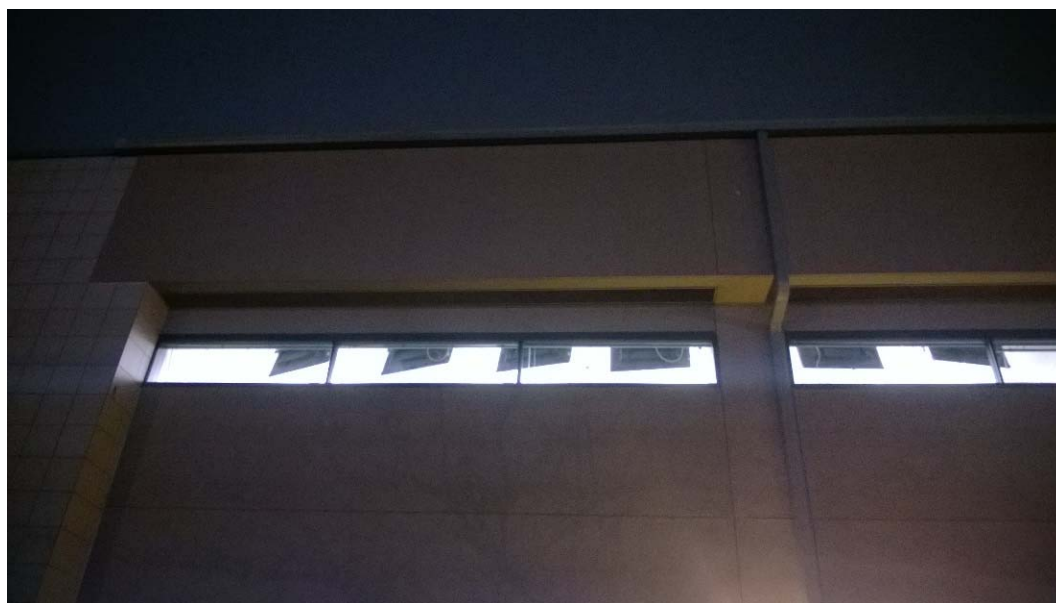
Building exterior on the north wall of the 911 Call Center.

Example of heating coming from beneath the soffit.

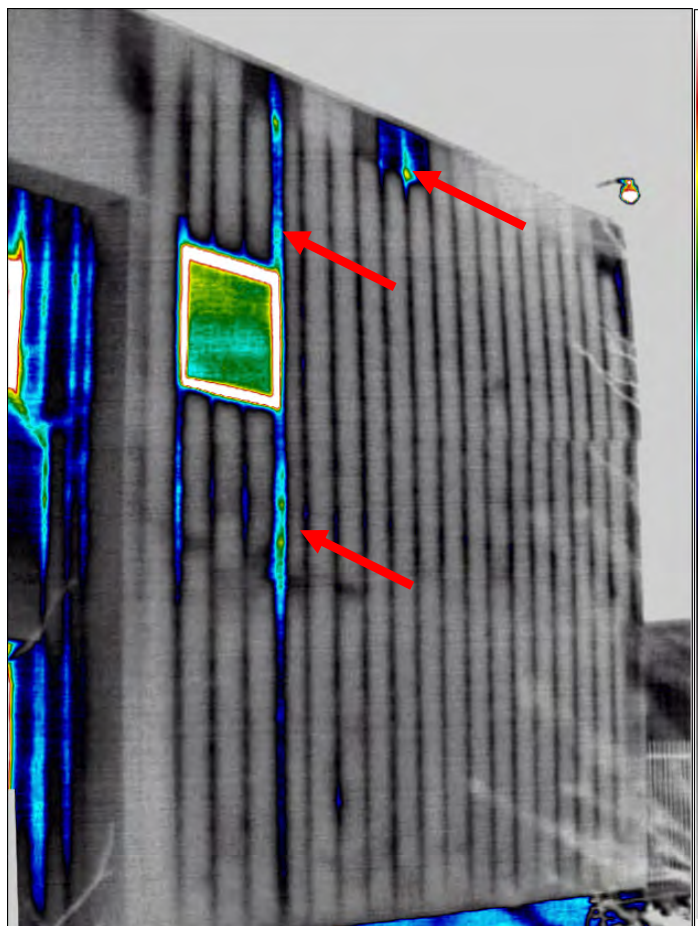
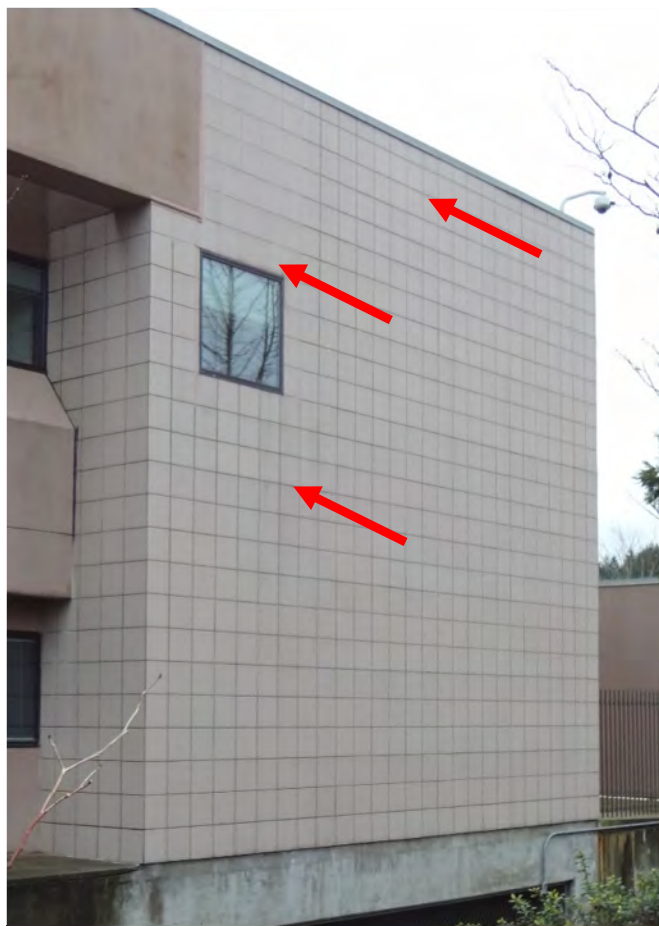
South wall exterior at the Southeast corner.

Thermal bridging above and below the window and along the parapet.

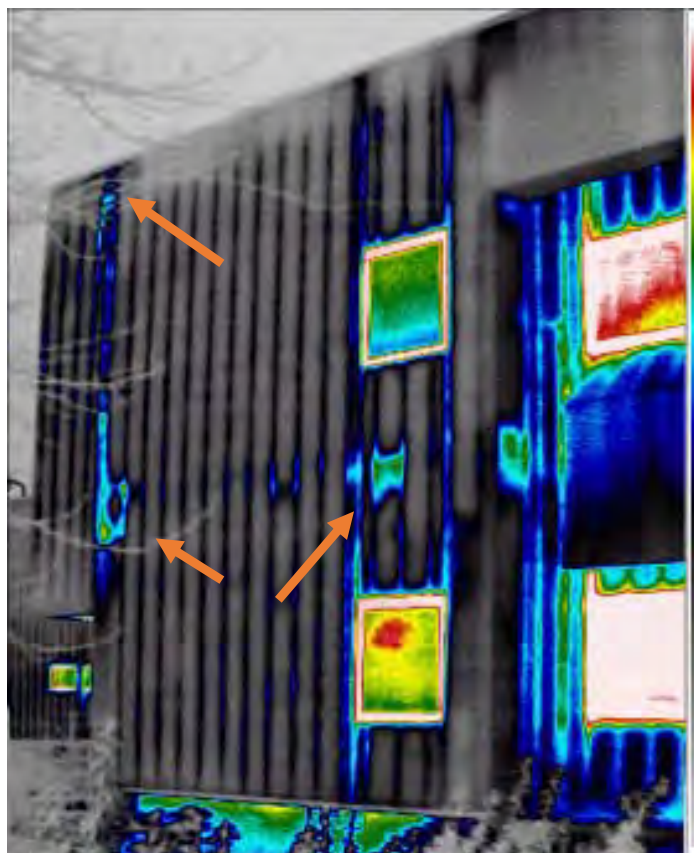
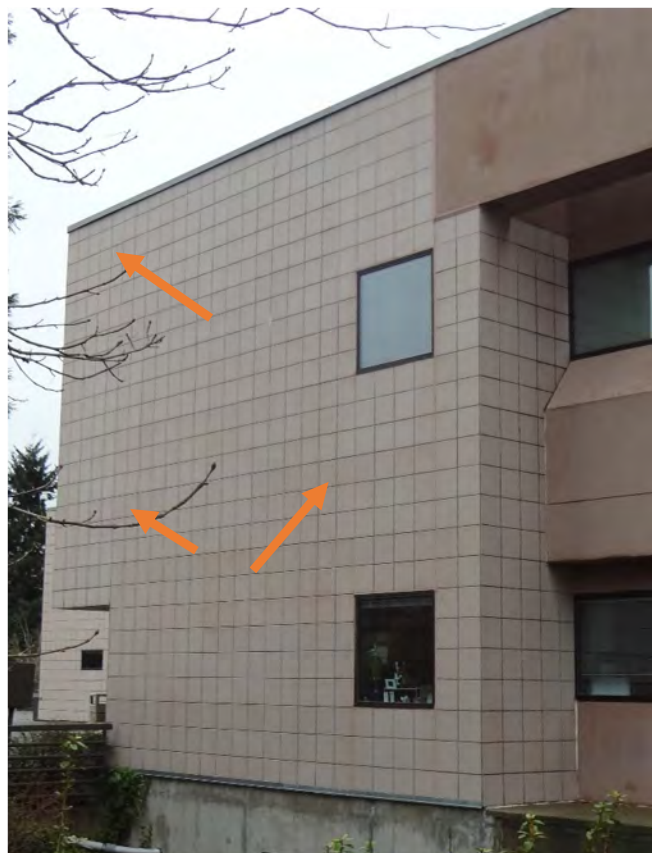
South wall exterior at the Southwest corner.

Thermal bridging above and below the window and along the parapet, and the corner of the building overhang for the entrance.

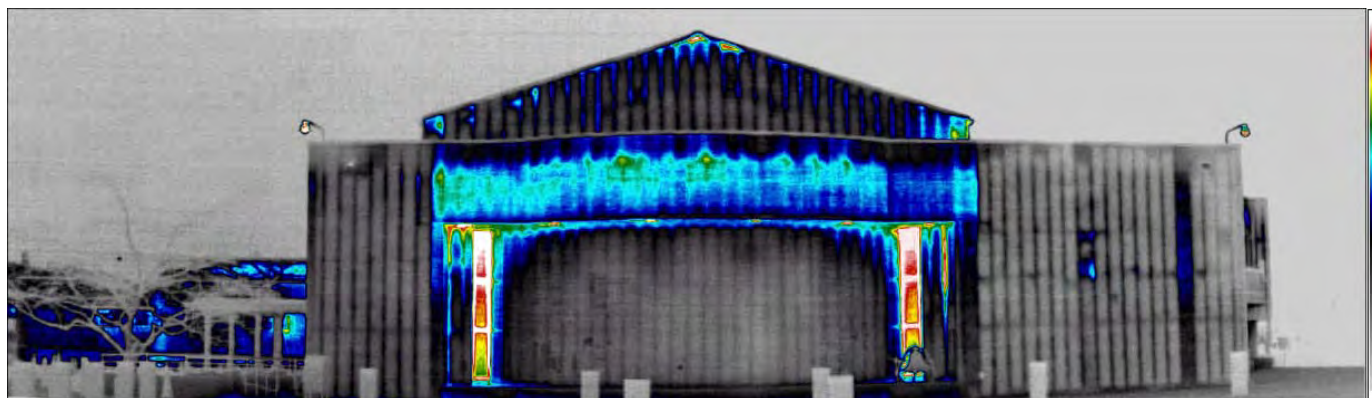
West end exterior of the building.

Thermal bridging in the overhead wall section on the far west side of the building.

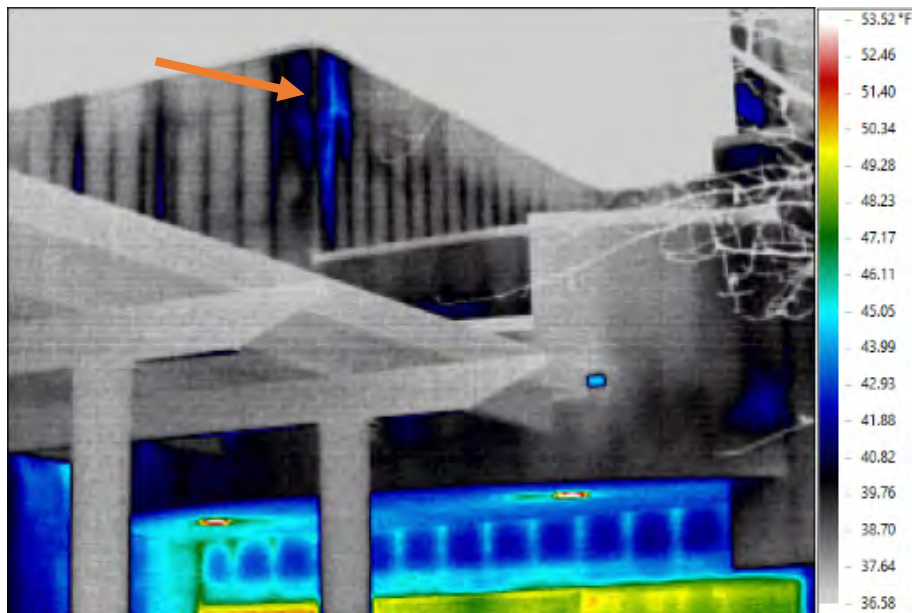
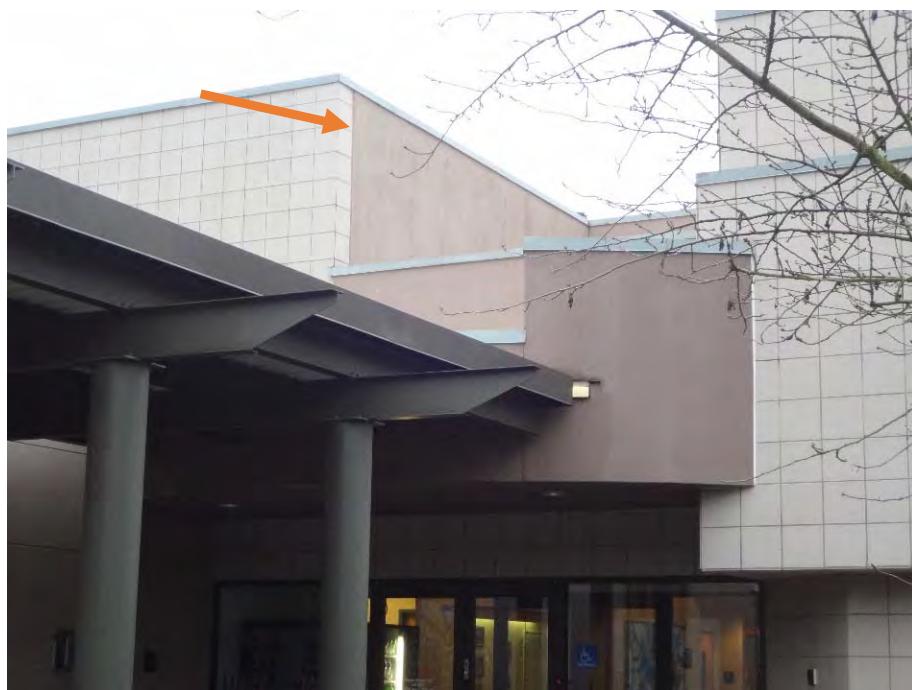
North entrance, building exterior.

Thermal bridging in northwest corner above the north entrance.

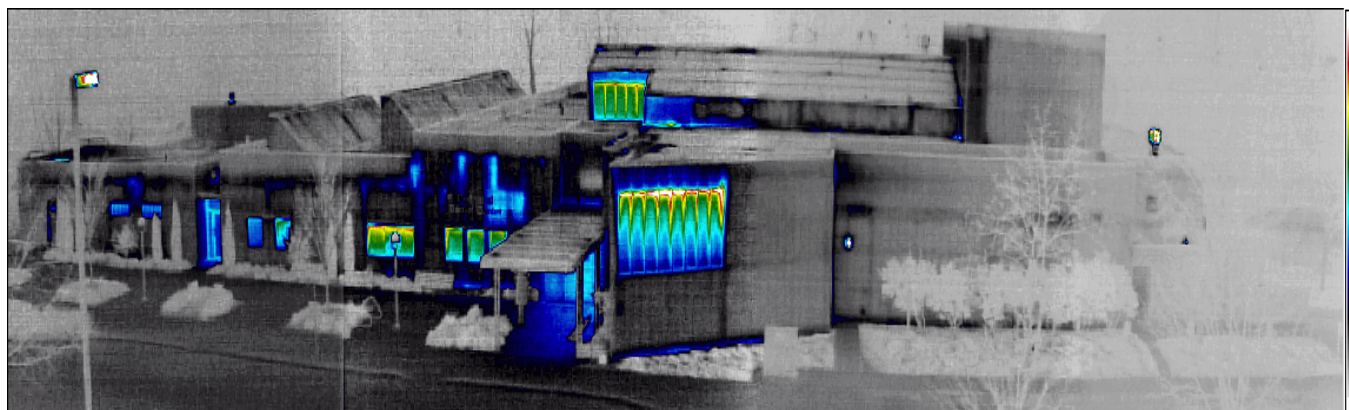
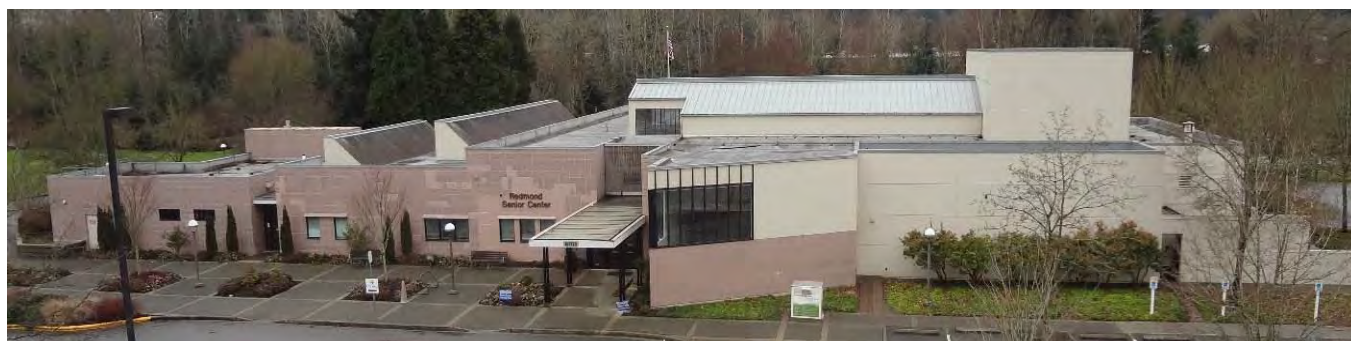
South rooftop, North wall of parapet to roof level.

Thermal bridging along center and base of the upper roof parapet/wall (south facing side).
