**CITY OF REDMOND**  
**FACILITY CONDITION ASSESSMENT**  
**15 MARCH 2014**

## **I. EXECUTIVE SUMMARY**

### **1.1 Introduction**

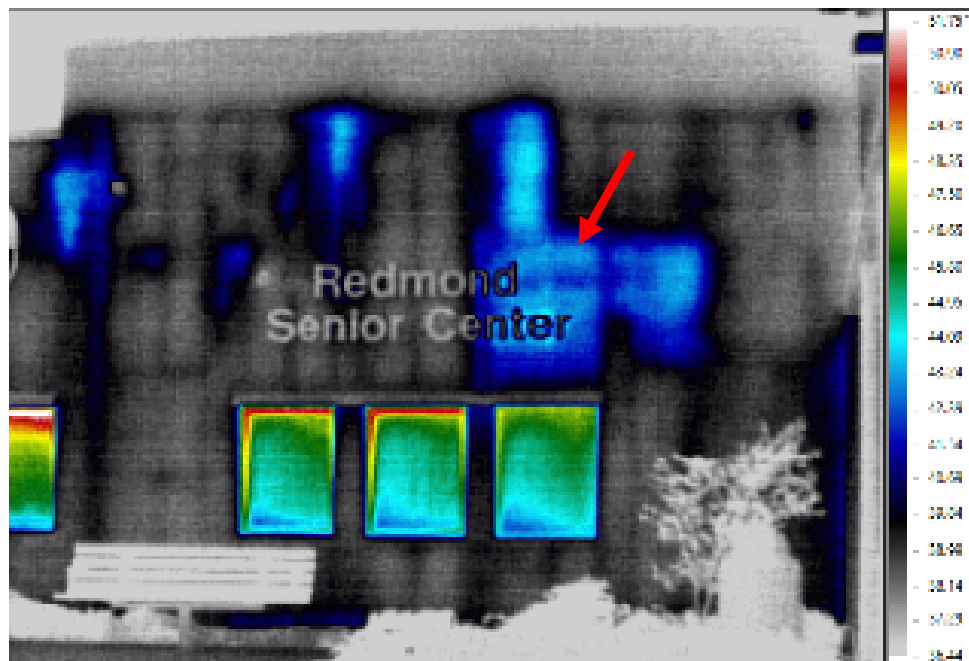
South exterior, front sign.

Thermal bridging through the east wall shows a random pattern above the windows.

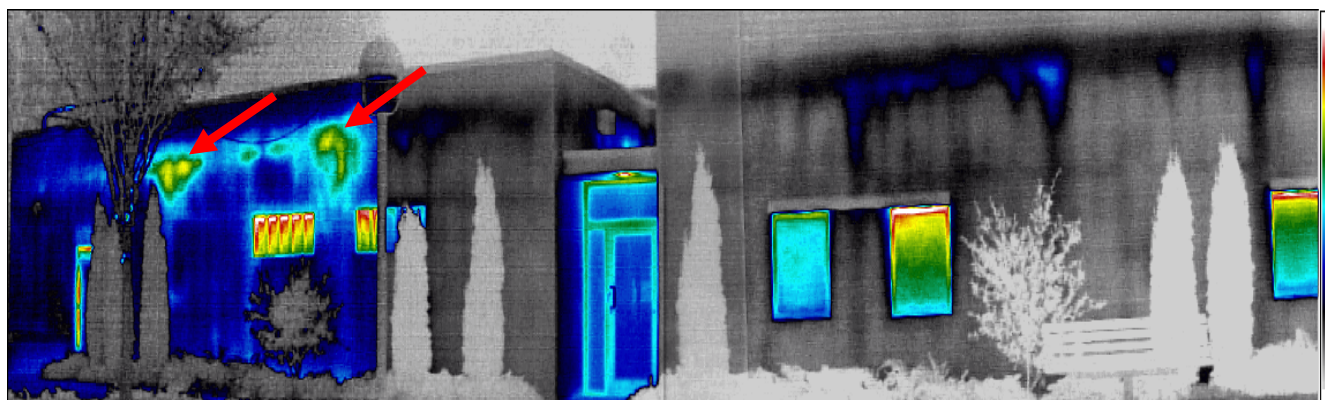
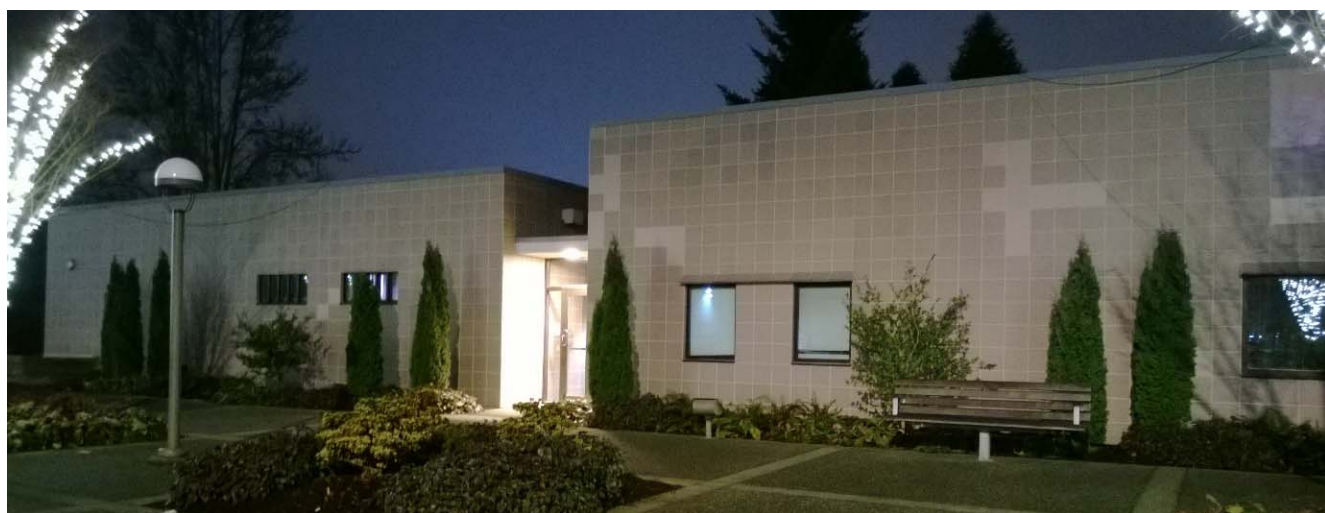
East wall, South end exterior.

Thermal bridging just below the region of the roof line, involving the base of the parapet wall on the reverse side.

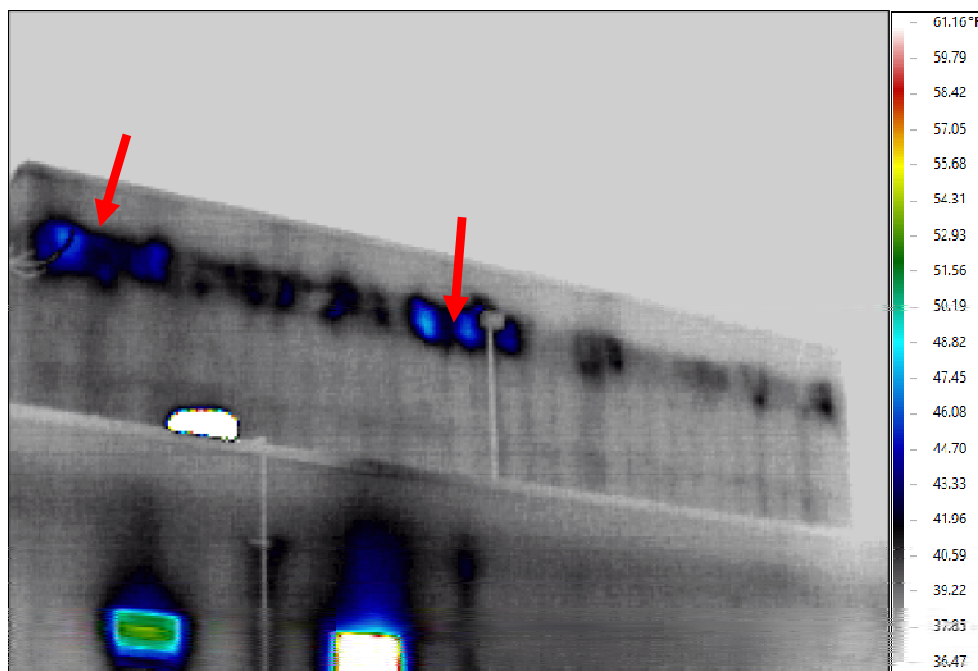
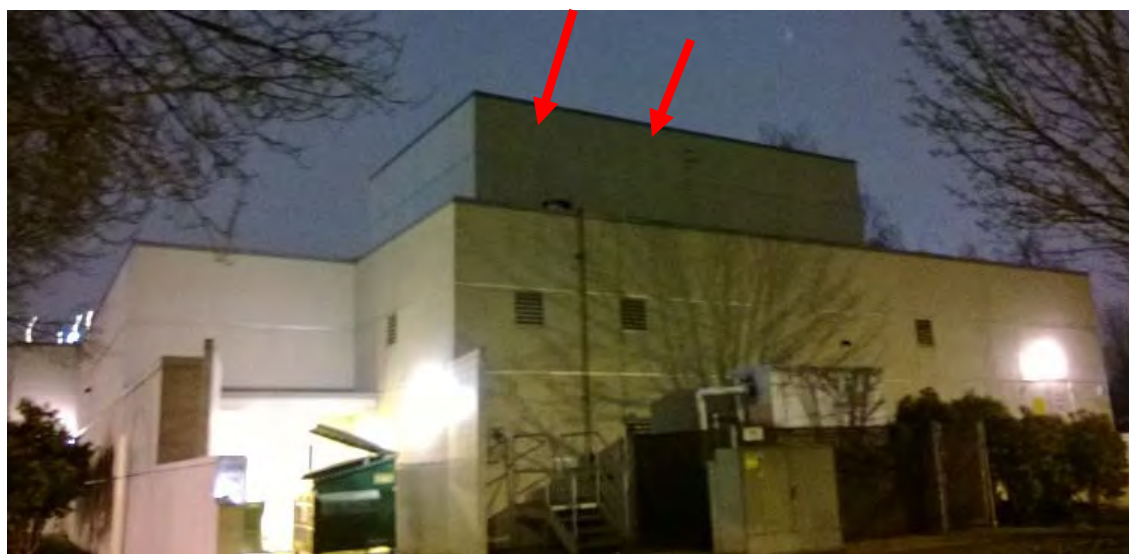
North end, penthouse exterior.

Thermal bridging just below the region of the roof line, involving the base of the parapet wall on the reverse side.

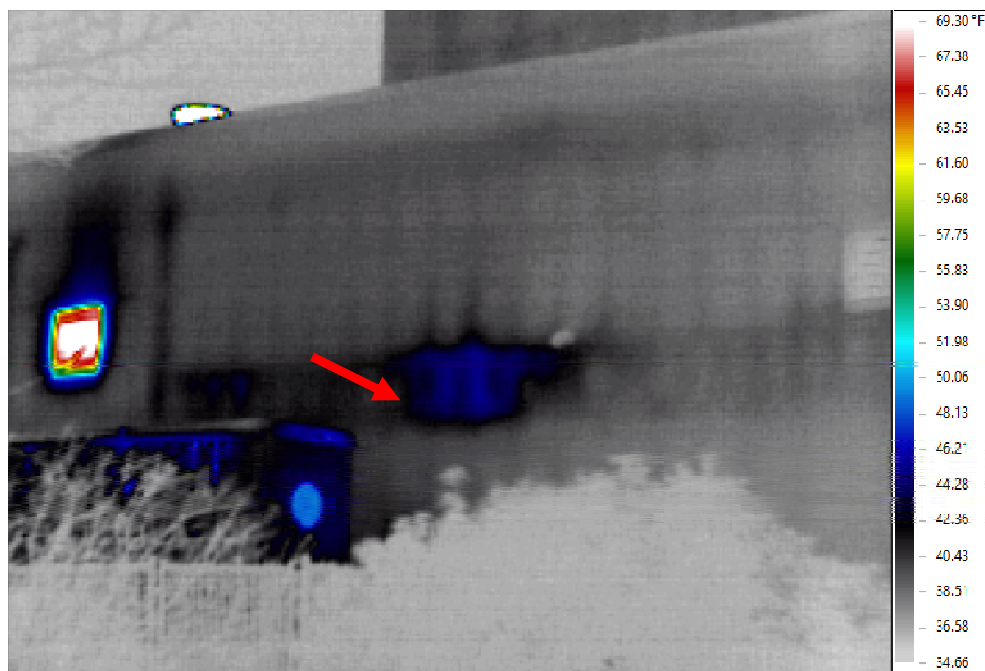
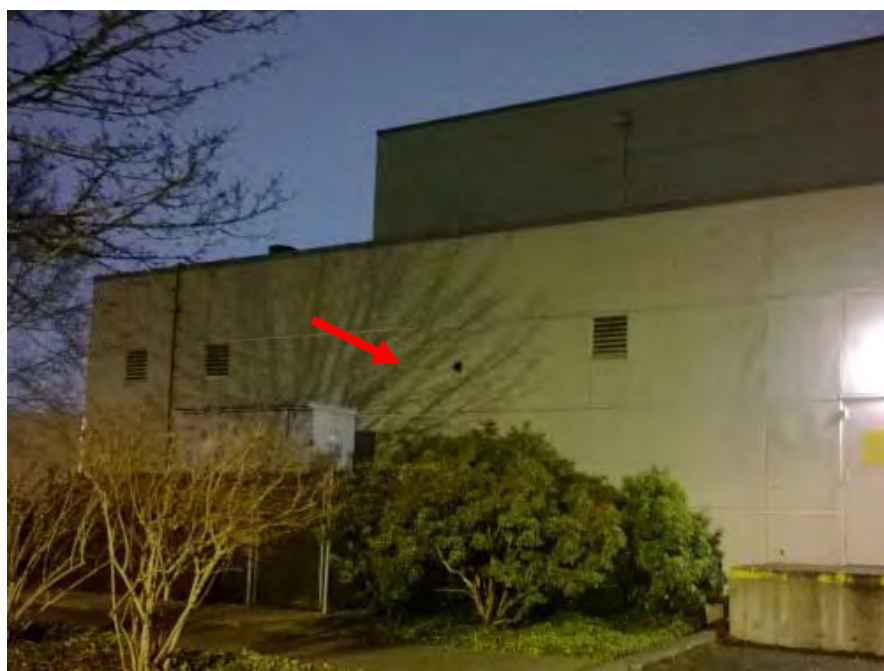
North end, mechanical area exterior.

Thermal bridging through the north wall next to the water tower/evaporator.

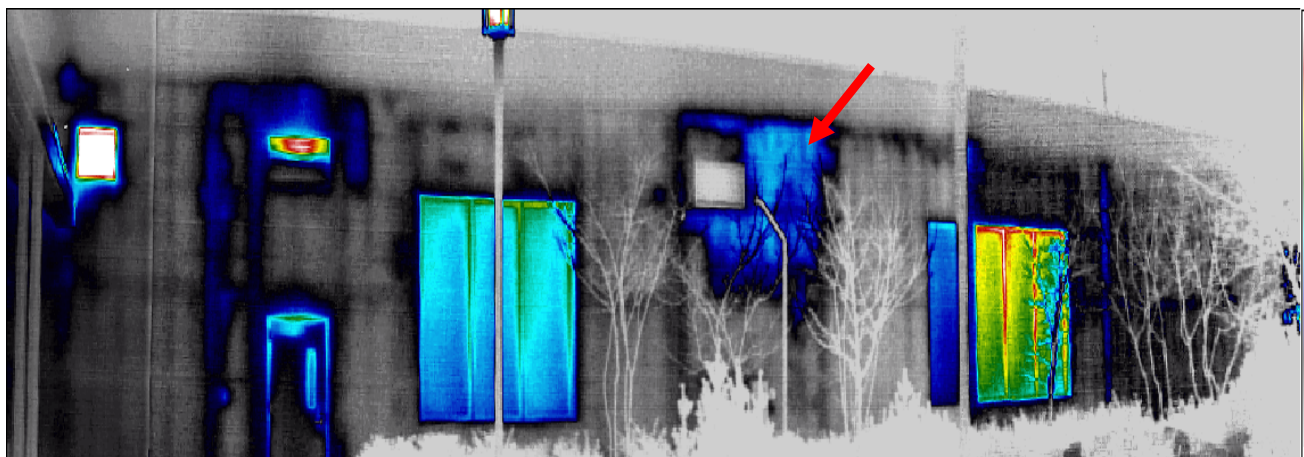
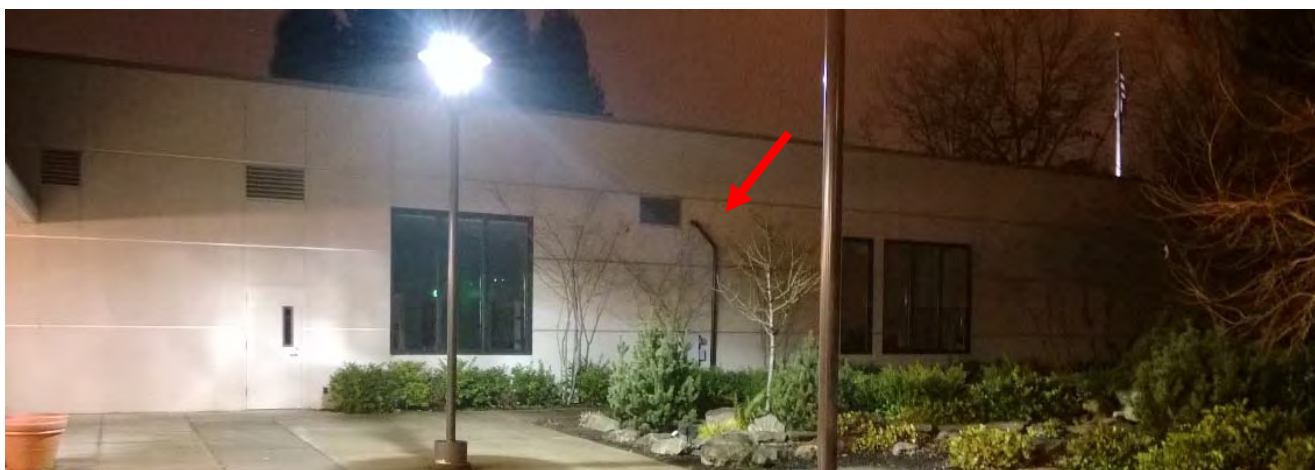
West wall, North face at east end, building exterior.

Thermal bridging in the wall section that is below the roof section that is showing wet insulation.

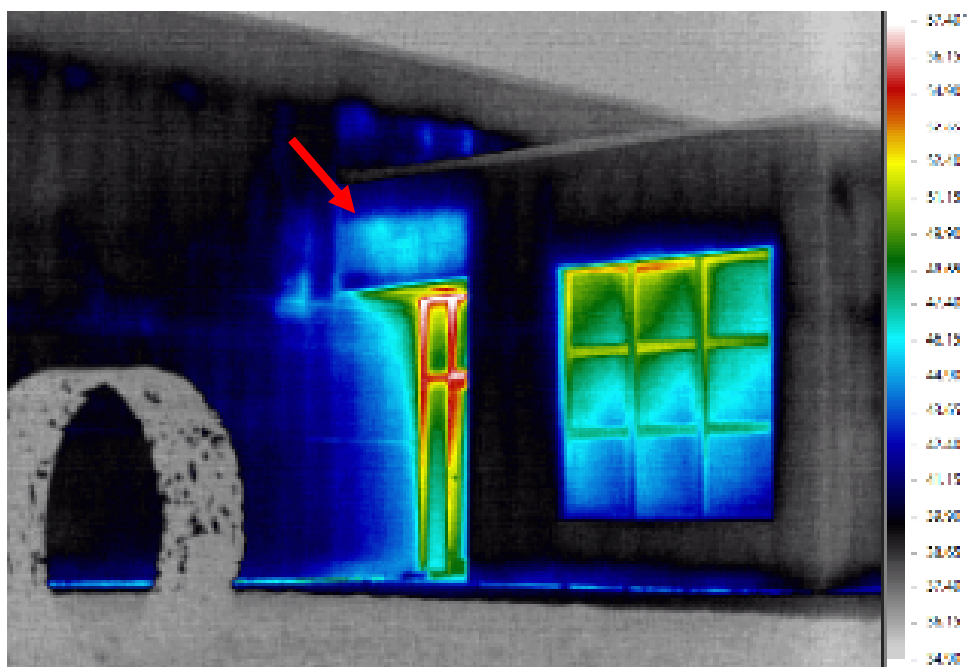
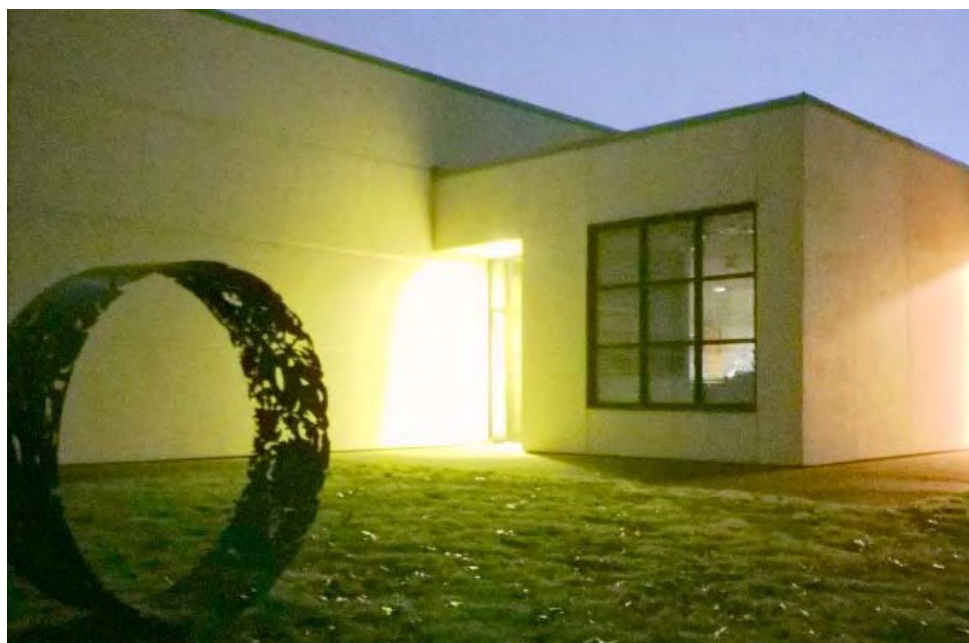
West wing, entrance exterior.

Area above entrance is showing thermal bridging in the entry way and around the door.
